***In situ* corrosion studies on iron shipwrecks and cannon**

The impact of water depth and archaeological activities on corrosion rates

Ian D MacLeod

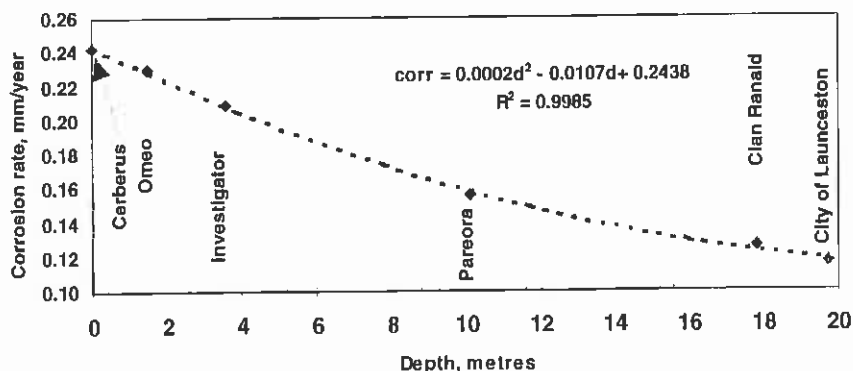
Figure 1. Effect of water depth on the corrosion rate of iron shipwrecks in Australian waters.

the cast iron propeller shaft of HMVS *Cerberus*. When the corrosion data was collected in 1994 the shaft was just lying proud of the seabed in a very fine silty deposit. Clearly the 68% lower corrosion rate is simply due to the fact that for long periods the propeller shaft has been either buried or largely sheltered by the rest of the vessel from the brunt of the wave action.²¹ This observation clearly indicates that the equation for calculating the rate of degradation of the iron wrecks should only be used for vessels in open waters. The effect of water depth on the annualised corrosion rate can be seen below in Figure 1.

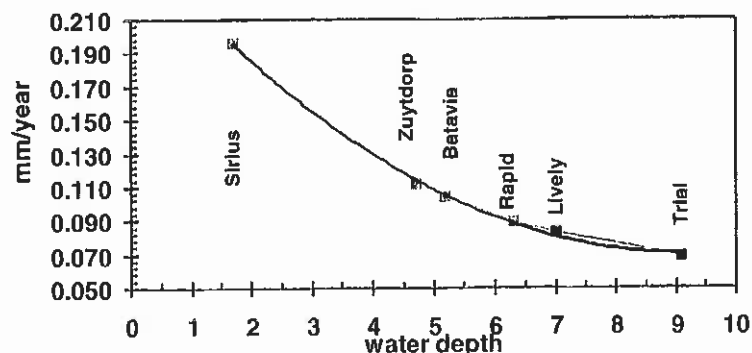
Figure 2. Effect of water depth on the rate of corrosion of cast iron cannon.

it was important to look only at data from cannon which had apparently been continuously exposed to open sea water. This reduced the data set to only six cannon, which ranged from the wreck of the English Eastindiaman *Trial* (1622) to the American China Trader *Rapid* (1811). The effect of increasing water depth on the rate of corrosion, as measured by the annualised depth of corrosion, is shown below in Figure 2.

Analysis of the data shown in the figure shows that the six points can be represented by equation 6, viz.,

which gives a minimum in the corrosion rate at 9 m, which is close to the depth from which the *Trial* cannon was recovered. It is interesting to note that the iron cannon corrosion rate predicted by equation 6 at zero water depth gives a rate of 0.259 mm/year, which is, within experimental error, the same rate as predicted for iron shipwrecks at zero water depth. This corrosion rate was observed for the iron at the splash zone of HMVS *Cerberus*. The other implication of these relationships of corrosion rate and water depth is that equation 6 predicts a minimum corrosion rate of 0.073 mm/year. This compares with the rate observed on the *Trial* cannon of 0.069 mm/year. Recent data from the tropical waters of Torres Strait off the Cape York peninsular in Queensland on the wreck of HMS *Pandora* (1791) relates to material recovered from a water depth of 30 m. The one cannon which had been found buried in the debris of the coral in 1983 was corroded to a depth of 9.5 mm or some 0.050 mm/year. The carronade for which measurements are available was corroded to a depth of 20 mm in 204 years or 0.098 mm/year. Although this carronade had corroded at a higher rate than equation 6 would have predicted, by some 35%, it should be noted that this piece of ordnance was associated with nearby copper artifacts, which would have exerted a significant galvanic effect and so increased the corrosion rate of the gun. The apparent elevation of the carronade corrosion rate on the wreck of the *Rapid* due to long-range galvanic coupling (proximity corrosion)^{4,24} is an increase from 0.072 to 0.096 mm/year or some 33%, which is the same as the values observed on the *Pandora* carronade.
