The Effects of Chloride Ions on the Corrosion of Aluminium Alloys used in the Construction of *Australia II*

Ian D MacLeod and David P Kelly

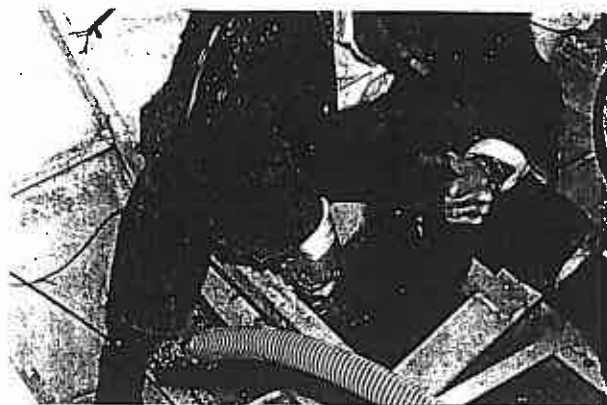
During the flushing and cleansing operation in the bilge area a small rectangular piece of aluminium was noticed. This piece was approximately 1/2 mm thick, 1 cm wide and about 4cm long and was lying flat on the hull plates. When this was removed from the surface of the hull plate the underlying metal was found to be deeply pitted. During the inspection all sorts of fragments of insulated copper wiring and stainless steel nuts and washers were removed. All of these would have had an accelerating effect on the corrosion phenomena. Copper ions will react with aluminium in the presence of chloride ions to produce metallic copper (cemented), which acts as an active site for the reduction of oxygen (Annamalai & Hiskey 1978). Since the reduction of oxygen on the aluminium alloy surface is often the rate-determining step in the corrosion reaction, any process, which facilitates this step, will have a most detrimental effect on the stability and durability of the alloy. The areas of most severe corrosion had lost at least 2mm, or some 40% of the total original thickness of the hull plate. The wet areas showed extensive pitting corrosion, with large bubble-like formations of a gel style precipitate of $\text{Al}(\text{OH})_3$ around active pit formations (Figure 3).

Figure 3. Initial inspection, shiny areas in liquid are bubbles of hydrogen gas, June 1987.

Corrosion of the hull-plates was initially halted by siphoning off the foul smelling deep brown liquid, swabbing the pits before scrubbing down the affected areas with local tap water, which averages 120 ± 25 ppm chloride. Tap water was chosen as this form of water was the only one available in the storage facility, which was located more than 8km from the conservation laboratories in Fremantle. There was the additional complication of the hazards of trying to get water up a rickety old wooden ladder to *Australia II*. After washing, the hull-plates were dried with a hot air gun in an attempt to rapidly form a coherent passive oxide film. However, this simple solution proved to be totally ineffective since fresh outbreaks of the initial frothy corrosion products on top of the pit sites, showed that simple swabbing was not effective at managing the corrosion process. Changes in relative humidity had allowed the aluminium surface to absorb water and propagate rapid corrosion in the pits. The configuration of the mast box prohibited access to the worst corrosion site and proper drying was impossible.

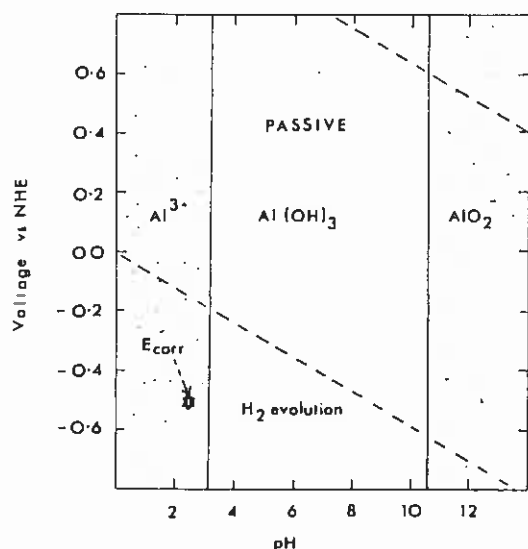
Figure 4. Pourbaix diagram showing location of E_{corr} in the zone of film free active corrosion.

symbol locates the pH and E_{corr} of the pit listed in Table 1 in the zone where the free Al^{3+} ion is the thermodynamically stable form of aluminium i.e. the metal is in a zone of active corrosion (Pourbaix 1974). Analysis of the sewer solution showed a chloride content of 13,100ppm, compared with normal seawater, which had a chloride content of 18,600 ppm. This indicates that the normal hosing down procedures had been at least partially effective in removing the bulk of the salty water from the interior of the vessel. Given the high concentration of chloride ions, it is likely that the ionic species present in the pits would have included some aluminium chloride complexes. Gas chromatography confirmed that, apart from salinity, the solution contained amino acids and a high content of urea. This analysis is consistent with the oxidation of human urine and sweat, which had accumulated inside the vessel during its service life as a racing yacht.

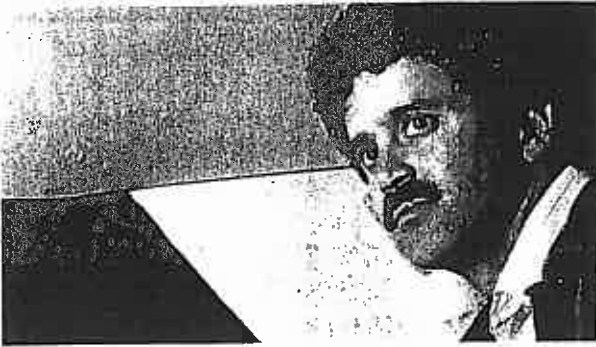
During the conservation treatment, the hull was separated from the keel to facilitate an inspection, as our previous inspections had shown that there were signs that seawater had penetrated the bedding compound and the interface between the two surfaces. One of the effects of ingress of water at the interfaces between the paint film, the micro-balloons and metal is blisters forming beneath the painted surface (Figure 5).

Figure 5. View of bubbles underneath the finished painted hull surface, June 1987.
