***In-situ* Corrosion Studies on Wrecked Aircraft of the Imperial Japanese Navy in Chuuk Lagoon, Federated States of Micronesia**

Ian D. MacLeod

Western Australian Museum Collections and Research Centre, Kew Street, Welshpool, Western Australia 6106

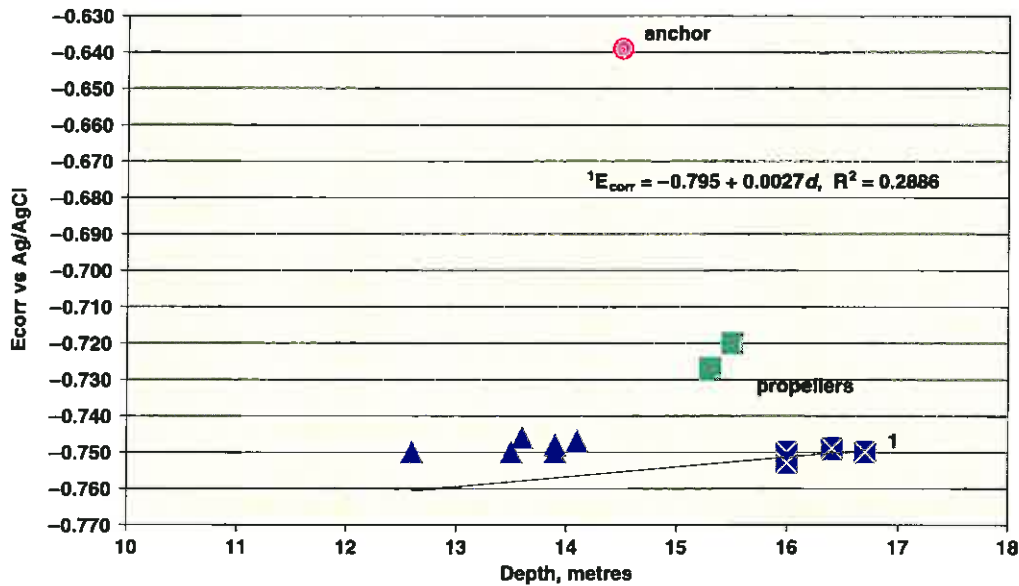
Since aluminium alloys have widely different values it is important to group the data according to alloy functionality when reviewing the impact of parameters such as water-depth. The values for the 'Duralumin' type of skin-sheeting from the starboard wing, wing-float, fuselage and lightweight frame showed an anodic shift of 2.7 millivolts per metre of increasing depth but the scatter of the data (Fig. 2) gave an R^2 of only 0.2886. A similar slope was observed for the E_{corr} data from the cowling, cockpit and engine nacelle

Figure 2. Plot of E_{corr} for the aluminium alloys on the *Emily* flying-boat as a function of water-depth.

The intercept error of ± 0.017 volts is small and the error in the slope was ± 0.0023 volts per metre. The difference in E_{corr} of the propellers and the skin on the *Emily* was 25 mV while on the *Judy* dive-bomber they were within a few millivolts of each other. The 43 mV more anodic E_{corr} of the tail than other parts of the skin is likely to be due to a difference in alloy composition. One area of the wing had a lump of concretion on it and the underlying pH was greater than 11 times more acidic (δpH of -1.05) than the average. It is likely that the reason why the local E_{corr} of the wing section that had the lower pH under the concretion did not have a dissimilar potential to the other areas is that the pH reflects the micro-environment while the E_{corr} reflects the average voltage of the corrosion cell that consists of the areas that are electrically connected to the point of measurement. Similar behaviour has been noted on iron shipwrecks (MacLeod, 2002).

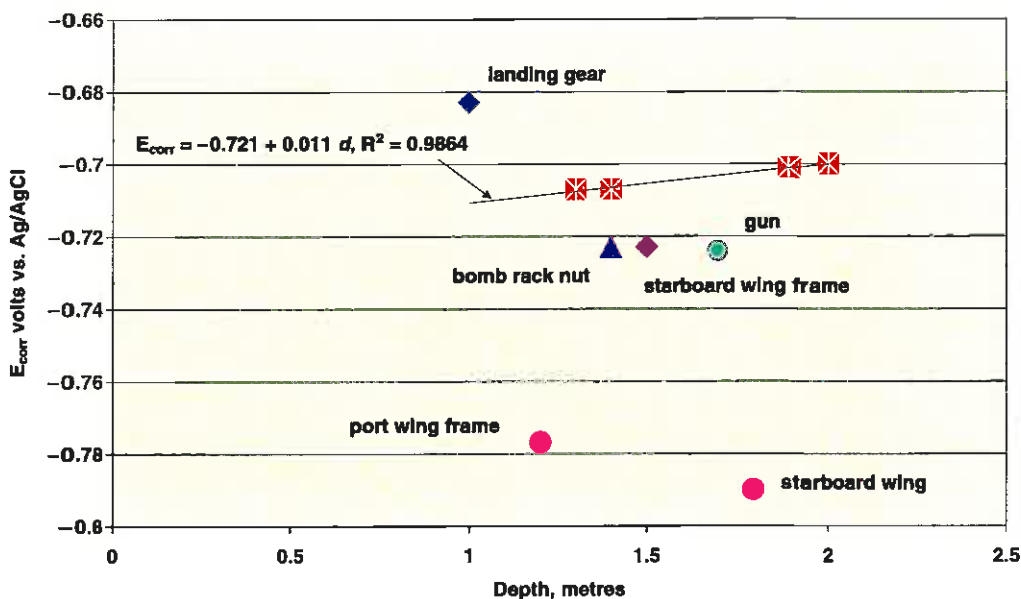
Figure 3. Corrosion potentials of the *Zeke* fighter plane off Eten Island.

Narayan, 1989). The difference of 77 mV in the corrosion-potentials on two sections of the port wing is probably a reflection of the different alloys that were used in its construction (Table 2). Most of the E_{corr} values fall into either that with a mean of -0.704 ± 0.004 V and the other at -0.723 ± 0.002 volts. When the E_{corr} data is plotted as a function of water-depth (Fig. 3) the linear regression had an R^2 value of 0.9864 and it gave equation 3

where d is the water-depth in metres. The intercept error was ± 2 mV and the slope had an error of ± 0.0009 volts per metre. The apparently greater sensitivity of E_{corr} on water-depth than observed on the *Emily* (14.4 ± 1.4 m) and *Judy* dive-bomber (2.5 ± 0.4 m) is not surprising as the Eten Zeke site (1.5 ± 0.3 m) will have strong surface mixing. Since the gun pH at 8.22 is more alkaline than the surrounding sea-water at pH 8.12 and is much more alkaline than the mean pH of 7.74 ± 0.05 for the rest of the wreck indicates that it is being cathodically protected by corroding aluminium alloys. The E_{corr} of the landing-gear reflects the differences in composition between cast-aluminium alloys and wrought and extruded alloys on other parts of the wreck.

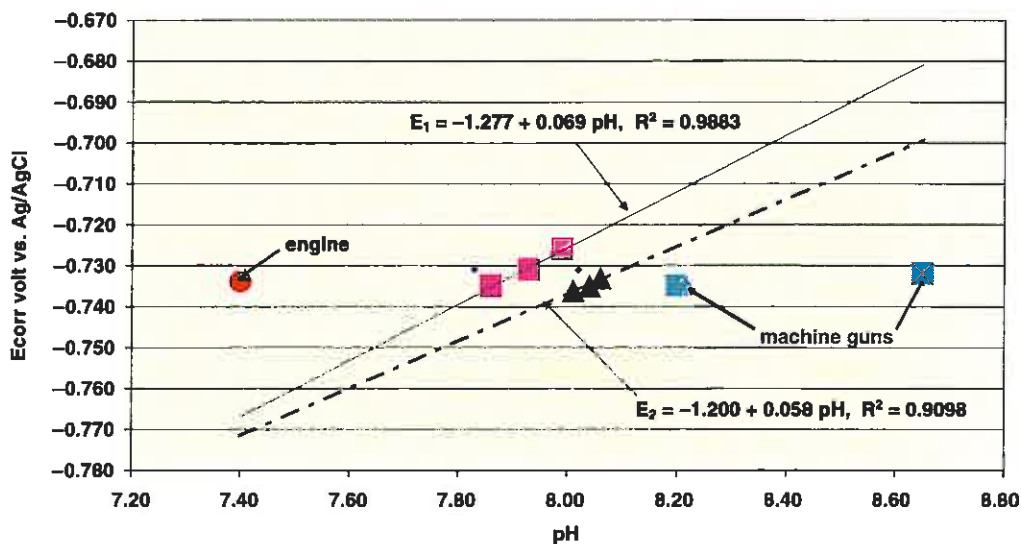
wings into two pieces. The mean E_{corr} was -0.733 ± 0.003 V, which is nearly 30 mV more negative than the Eten Zeke (Table 1). The pH values of 8.20 and 8.65 for the two guns indicate that the surrounding aluminium alloys are actively protecting them. Its general micro-environment is best seen in a Pourbaix plot (Fig. 4) where the E_{corr} values are plotted against the pH of the objects. The two machine-guns and the concreted spot on the engine have atypical pH to other parts of the site that indicate a clear connectivity between E_{corr} and pH. Two sub-sets of data have a common slope of $+64 \pm 8$ millivolts which indicates that one proton is involved with each electron. The corresponding equations are

The difference of 77 millivolts in the intercepts is due to compositional differences in the aircraft skin and frames since addition of an extra 2% copper in solid solution with aluminium results in a 60 mV difference in E_{corr} of the wrought alloys (Table 2). Despite the difficulties in gaining accurate pH data on submerged aircraft wrecks in Chuuk the variation in pH with E_{corr} for the upside-down Zero provides an insight into the

Figure 4. Plot of pH versus E_{corr} for the upside-down Zero off Eten Island.

corrosion mechanism. Thermodynamic data on aluminium complex ions shows that $\text{Al}(\text{OH})_3$ is the dominant form at pH values above 7 at room temperatures, $\text{Al}(\text{OH})_2^-$ in the range 7–6 and $\text{Al}(\text{OH})^{2+}$ between 6–5.5 (Lowson, 1974). The gelatinous nature of the corrosion-products on the aluminium alloys is consistent with them being aluminium hydroxide gels mixed with algae.

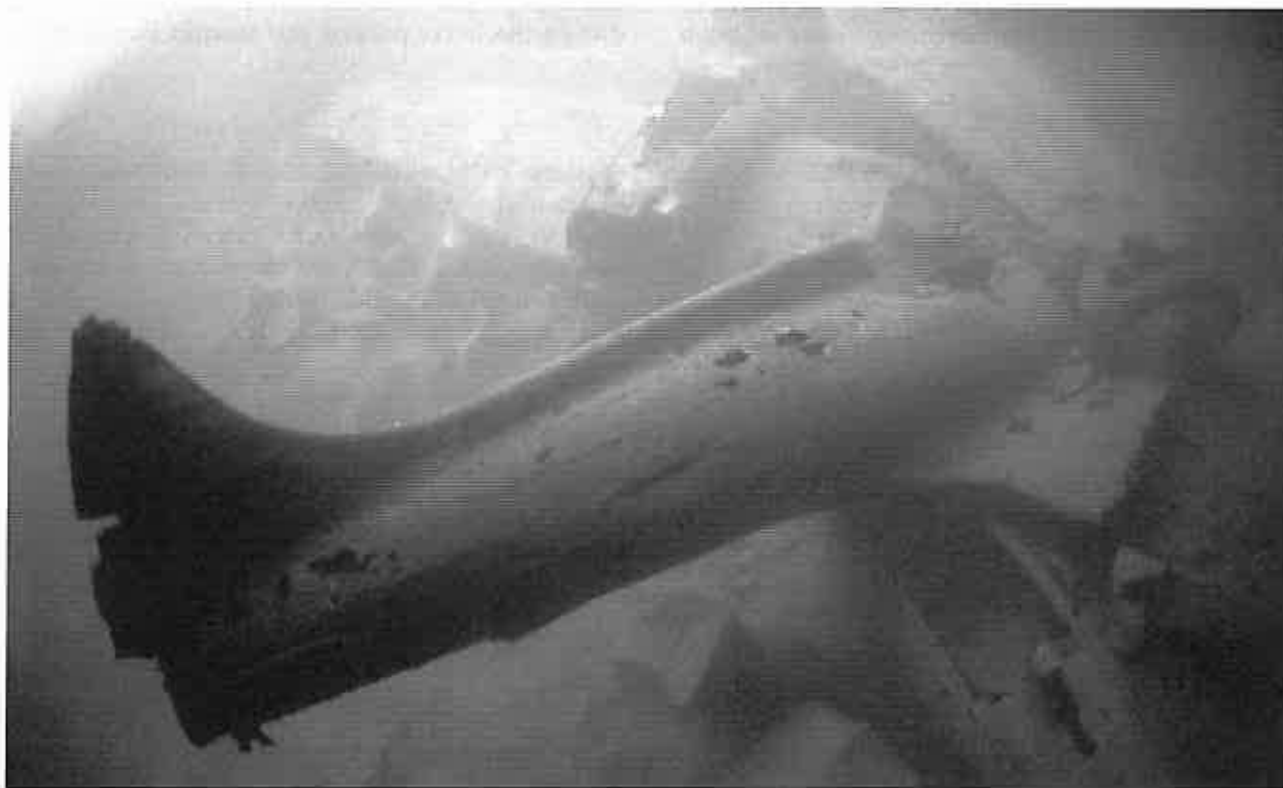
Diving conditions limited measurements inside the forward hold of the *Fujikawa Maru* to three aeroplanes. Subsequent historical analysis (Jeffery, 2004) showed that one of the planes was a Mitsubishi A5M (Type 96 Carrier Fighter) to which the USA gave the code-name *Claude*, the world's first mono-wing shipboard fighter (Fig. 5). The two *Zeros* had a mean E_{corr} of -0.747 ± 0.006 volts while the *Claude* was -0.710 volts and there was no real difference in the pH values which had a mean of 7.63 ± 0.02 (Table 1). The aircraft are clearly electrically isolated from the steel in the hold for otherwise they would have been selectively corroded to protect the surrounding iron ship. A Japanese aircraft-production worker

Figure 5. Inside the hull of the *Fujikawa Maru* with the *Claude* in the foreground and one of the *Zeros* behind with the painted numerals '39' on the highlighted section. (Bill Jeffery)
