A new corrosion mechanism for iron shipwrecks in seawater: a study of the *Fujikawa Maru* (1944) in Chuuk Lagoon, Federated States of Micronesia

Ian D MacLeod
Western Australian Museum
Locked bag 49
Welshpool DC
Western Australia 6986
Australia
Fax: +61 8 94272839
E-mail: ian.macleod@museum.wa.gov.au
Web site: www.museum.wa.gov.au

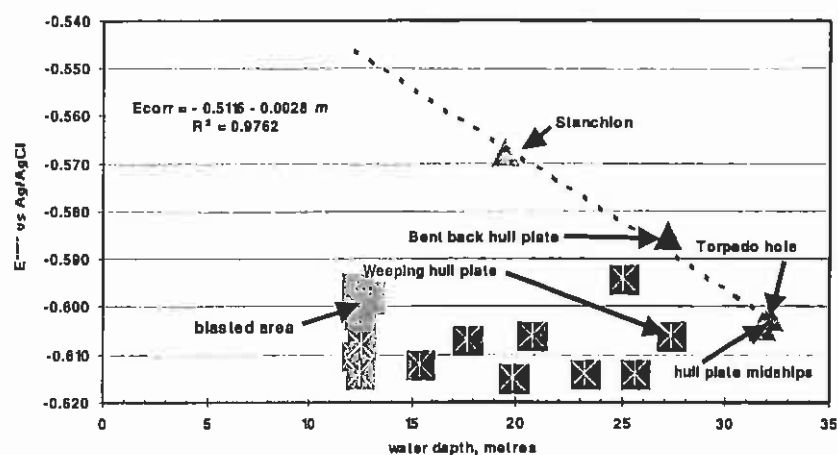
Figure 3. Plot of corrosion potentials vs. water depth on the *Fujikawa Maru*

The similarity of most of the corrosion potentials seen in Table 1, which cover a depth range of 5–31.8 m, shows that this parameter is insensitive to the changing water depth owing to most of the wreck still functioning as an electrical entity. Some parts of the wreck site appear to be at least partly electrically isolated from the main vessel, for when the data from the portside deck stanchions, a piece of bent-back hull plate near where the torpedo entered, the torpedo hole and some hull plate in the midships, their values of E_{corr} fall with increasing depth. These sections of the vessel have either suffered stress or have a work history that means they are no longer in direct electrical contact with the rest of the vessel. All the E_{corr} and depth data are summarized in Figure 3, which illustrates how the values of the various measurement points vary as a function of water depth. For these six measurement sets there was a strong correlation between the E_{corr} and depth; the linear regression (Equation 1) had an R^2 value of 0.9762:

where d is the water depth in metres. This move to more cathodic E_{corr} values of 2.8 mV/m is much less than the average values observed for open water wrecks where the voltage falls by 18 ± 2 mV/m, such as on the largely intact iron wreck the *City of Launceston* (1876) where the E_{corr} fell by 16.5 mV/m (MacLeod 1988, 2002).

The data listed in Table 1 and illustrated in Figure 3 are consistent with major damage to the *Fujikawa Maru* from the action of dynamite fishing. The impact of the explosions and the associated shock waves on the deck and hull plates were reflected in only very thin layers of concretion being present; and the deck had several sections where the masonry tipped drill bit went through the paper-thin residual metal. When the E_{corr} and pH data are plotted on an appropriate Pourbaix diagram (Pourbaix 1974) it becomes apparent that these two parameters are closely linked (North 1982). The electrically isolated parts of the wreck indicate an electrochemical process controls the pH and the E_{corr} on this wreck site. The linear regression for the six data points had an R^2 value of 0.8277 and their interrelationship is defined by Equation 4:

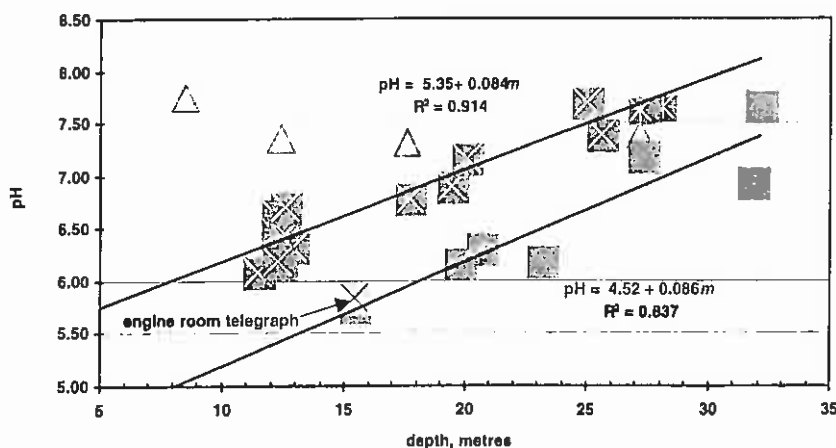
Figure 4. Plot of pH data on the *Fujikawa Maru* as a function of water depth

The pH data exhibit a much greater degree of variation with water depth than the corrosion potential data. Because concretion layers act as a semi-permeable membrane that separate the anodic (metal oxidation) and cathodic (oxygen reduction) sites, the varying thickness of this layer will also be reflected in the absolute values of pH (North 1976). Recently deconcreted and recolonized areas tend to give pH values around 7.5 ± 0.3 whereas the fully matured sections of the vessel gave much more acidic values. Analysis of the pH data reveals two sub-groups that have the same dependence on water depth but have different intercept values (Equations 2 and 3). The more acidic data set, which reflects the eight measurement points where there has been little disturbance of the site, is seen in diagrammatic form in Figure 4. A linear regression analysis on the 'older concretion data' gives a value of $R^2 = 0.837$ and Equation 2:

Statistical analysis of the regression data for Equation 2 has an intercept error of ± 0.37 and a value of ± 0.016 for the error in the slope. The corresponding data for Equation 3 has an intercept error of ± 0.12 and a slope error of ± 0.007 , which means that both equations have identical slopes and that the overall nature of the processes controlling corrosion is the same. The difference of 0.83 in the intercepts of Equations 2 and 3 simply means that the older concretion is nearly seven times more acidic than the newly formed material. The intercept value for Equation 2 is typical of the pH data recorded on marine iron in shallow waters (MacLeod 1989a). The average slope of 0.085 ± 0.001 pH unit per metre means that the acidity of the environment under the concretion decreases by approximately 22 per cent per metre of increased water depth. This in turn indicates that the corrosion rate is very sensitive to water depth.

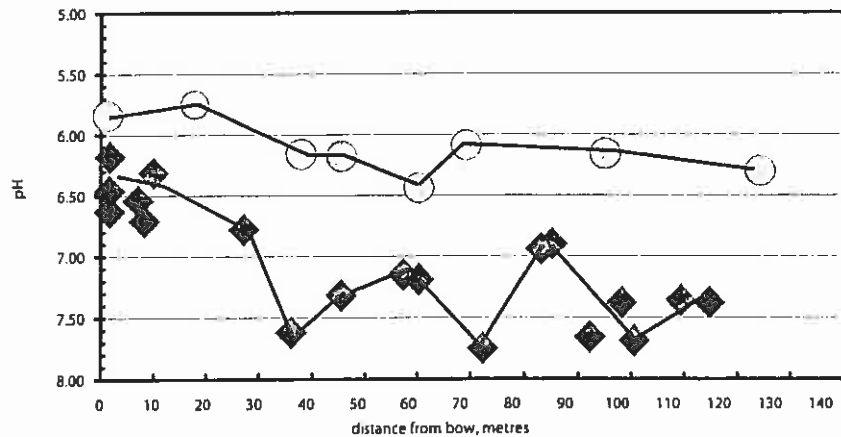
Figure 5. Surface pH on the *Fujikawa Maru* vs. distance from bow

with an R^2 value of 0.8948 and where d_g is the annualized corrosion rate in millimetres of graphitization per year of immersion as a shipwreck. Although the data set is very limited, the relation indicates that the surface pH provides a guide to the local corrosion rates. When the pH data are plotted as a function of the distance from the bow, some interesting trends emerge (Figure 5). The more acidic values (circles) relate to areas of the vessel where there is less evidence of deconcretion activity, and the diamonds reflect areas of thinner concretion thickness. A pH minimum (circles) occurs around 18 m and again near 70 m from the bow. There appears to be a similar trend in the more recently concreted zones (diamonds) in that the zone of highest acidity is around 10 m from the bow then 60 m and again near 85 m. When the pH data that conform to either Equations 2 or 3 have the intercept value subtracted and the result is divided by water depth, the data for the steel plating show up similar zones of higher acidity at 18, 45, 80 and 120 m from the bow, as shown in Figure 6. Similar pH minima that relate to localized turbulence of water movement were observed on the *City of Launceston* (1856) wreck (MacLeod 2002). The data for cast iron from the bow (circles) relate directly to the observed corrosion profiles, with lower values of the normalized pH corresponding to greater corrosion depths. The bridge structure, aft and fallen-mast have more alkaline values owing to their recent history of having been deconcreted.
