In situ conservation surveys of iron shipwrecks in Chuuk Lagoon and the impact of human intervention

Ian D MacLeod* and Vicki L Richards

Western Australian Museum

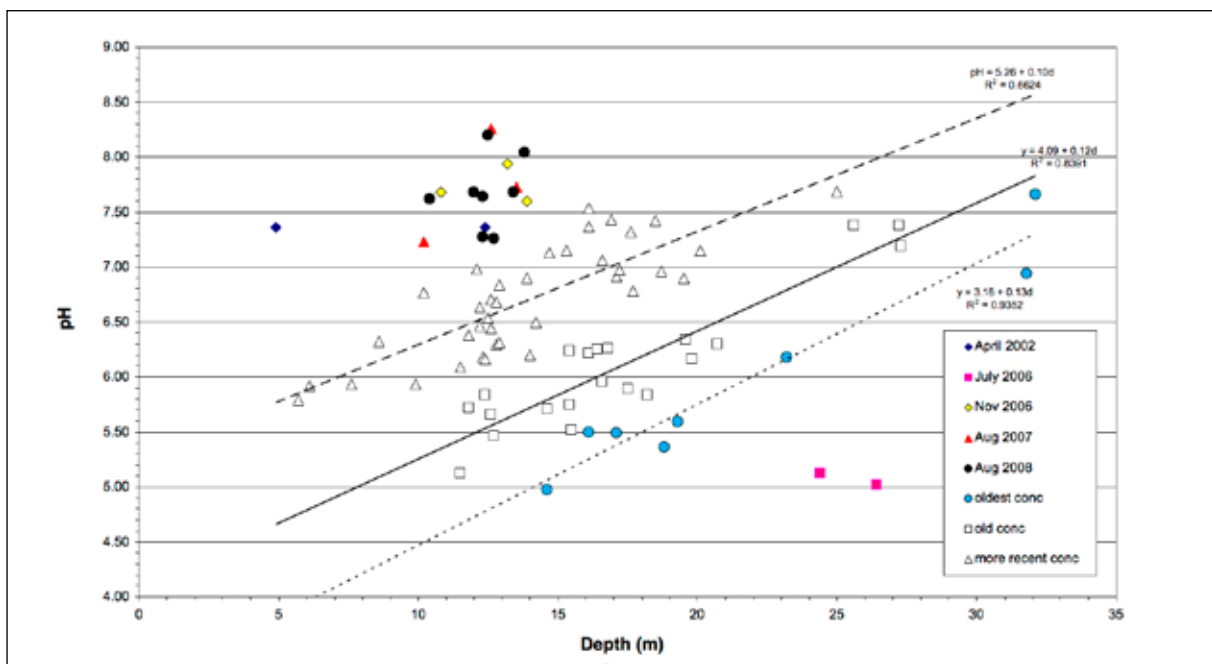
A plot of the metal surface pH versus water depth on the *Fujikawa Maru* (Figure 4) shows a systematic trend of increasing pH with water depth and this is simply a reflection of the fact that the rate of corrosion, as measured by the amount of acid produced from metal ion hydrolysis, is logarithmically decreasing with increasing water depth (MacLeod 2005). This graph also shows that the dynamite fishing affects the pH particularly in the shallower water range down to 15m, which covers the depth of the forward midships and bow sections of the vessel. Extensive exfoliation of the concretion has been noticed on the forward deck by the bow gun and on deck plates leading back to the bridge superstructure. The pH and depth data for the April 2002 field season has been reported previously in MacLeod (2005) but with the additional data collected over a further four seasons (July 2006, November 2006, August 2007, August 2008) it has become clear that it is possible to discern not only two types of concretion and pH relationships, but in fact there are three

Figure 4. Plot of metal pH versus water depth on the *Fujikawa Maru*.

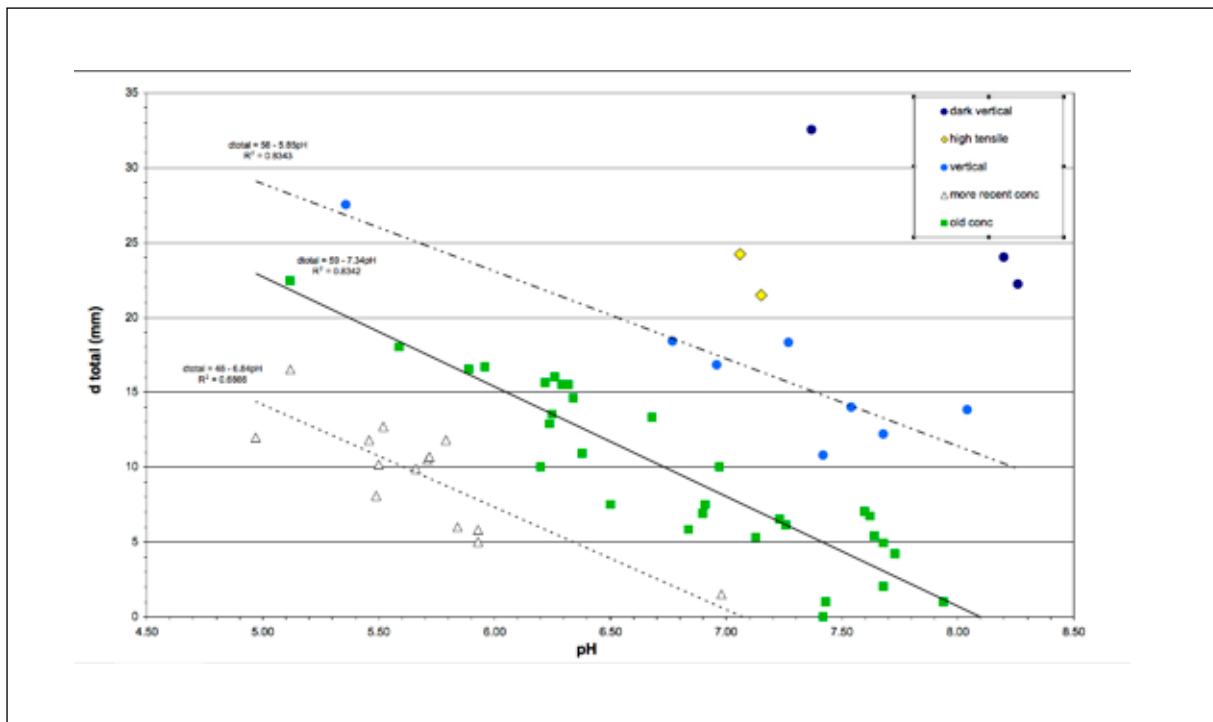
Figure 5. Plot of total concretion thickness versus metal pH on the Fujikawa Maru.

When all the total concretion and corrosion thicknesses (d_{total}) were plotted against the corresponding metal pH values (Figure 5) it was found that there were three main groups of data which correlated with the old concretion, the more recent concretion and the concretion found on vertical surfaces. Outlying data points on the more alkaline pH values and representing thicker concretion values were associated with the vertical surfaces that lay in shadow zones cast by the

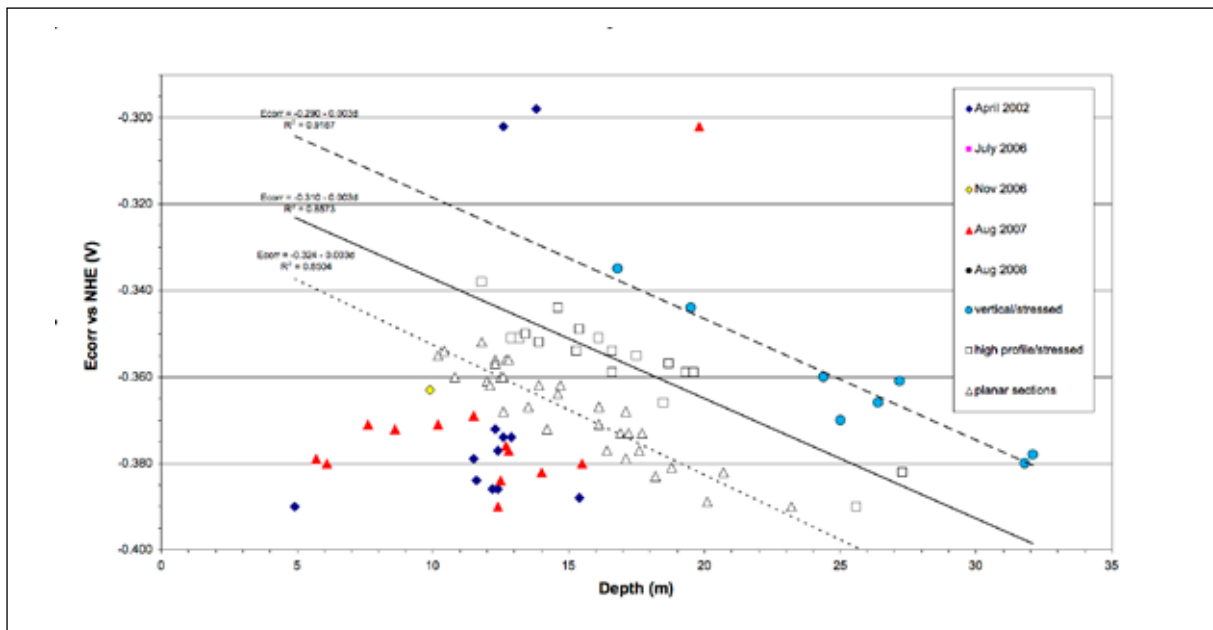
Figure 6. Plot of corrosion potential versus water depth on the Fujikawa Maru.

When the E_{corr} data from all field seasons for the *Fujikawa Maru* is plotted versus water depth (Figure 6), it is found that the voltages cluster according to a combination of the physical position on the wreck and the associated mechanical stresses on the elements. The vertically positioned and physically stressed (e.g. near the torpedo damage) sections of the ship have the highest, i.e. the least negative, E_{corr} values which are 20mV more anodic than the areas which can be described as having a high physical profile; many of these sections are also

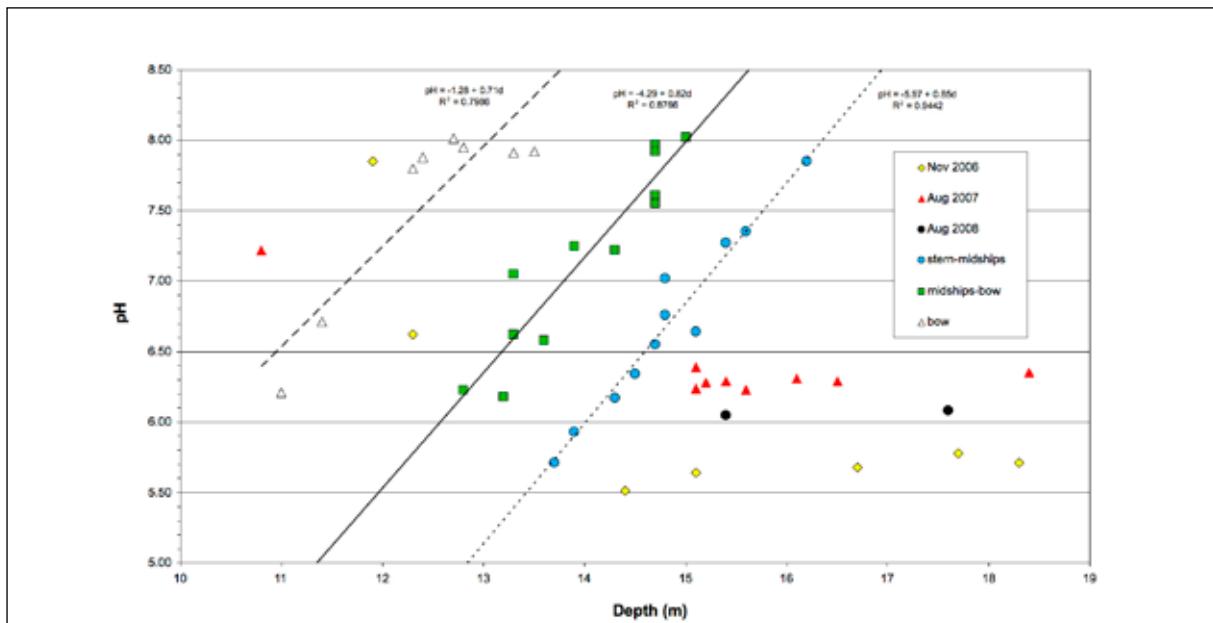
Figure 8 Plot of metal pH versus water depth on the Tonoas dock boat.

The pH versus water depth graph for the Tonoas dock boat (Figure 8) exhibits the same trend of increasing pH with increasing water depth as was evident on the *Fujikawa Maru* (Figure 4) for the same underlying reasons (i.e. decreasing corrosion rates with increasing depth), and the slopes of the three separate clusters of data points were the same within experimental error, indicating the same mechanism is controlling the corrosion rate. However, the average slope of the pH versus depth plots of the three data clusters observed from 56 measurement points on the Tonoas Dock Boat was 0.80 ± 0.08 which is much steeper than that observed on the *Fujikawa Maru*, where the mean slope of the pH versus depth plots was 0.12 ± 0.01 . The slope of the pH versus depth plot for the Tonoas dock boat was almost seven times that observed on the heavily disturbed *Fujikawa Maru* site. Given that the mean depths of both sites are quite similar at 15.4 ± 5.2 m for the *Fujikawa Maru* and 14.4 ± 1.7 m for the Tonoas Dock Boat, the significantly greater sensitivity of the Tonoas Dock Boat pH is likely to be a reflection of the underlying susceptibility of the iron corrosion mechanism to changes in the local micro-environment in the absence of a series of 'dynamite fishing' or similar deconcreting events such as occur during typhoons. This observation is supported by the intercept pH values of the three data sets at zero depth, which are significantly more acidic than the intercepts of the data point clusters

Review of the deeper stern data, located below the stern-midships regression line in Figure 8, showed that instead of the normal trend of increasing pH with water depth, the pH is essentially independent of depth. This indicates that the stern section of the vessel has a slightly different corrosion mechanism to that which has been commonly observed on other historic iron shipwreck sites. It is possible that the stern hull plates and general surroundings are electrically connected to the rudder and propeller that may be of different metal compositions and/or the engine, which remains intact inside the stern section of the wreck. It is therefore likely that the combination of galvanic coupling and the direct physical connection with the whole of the

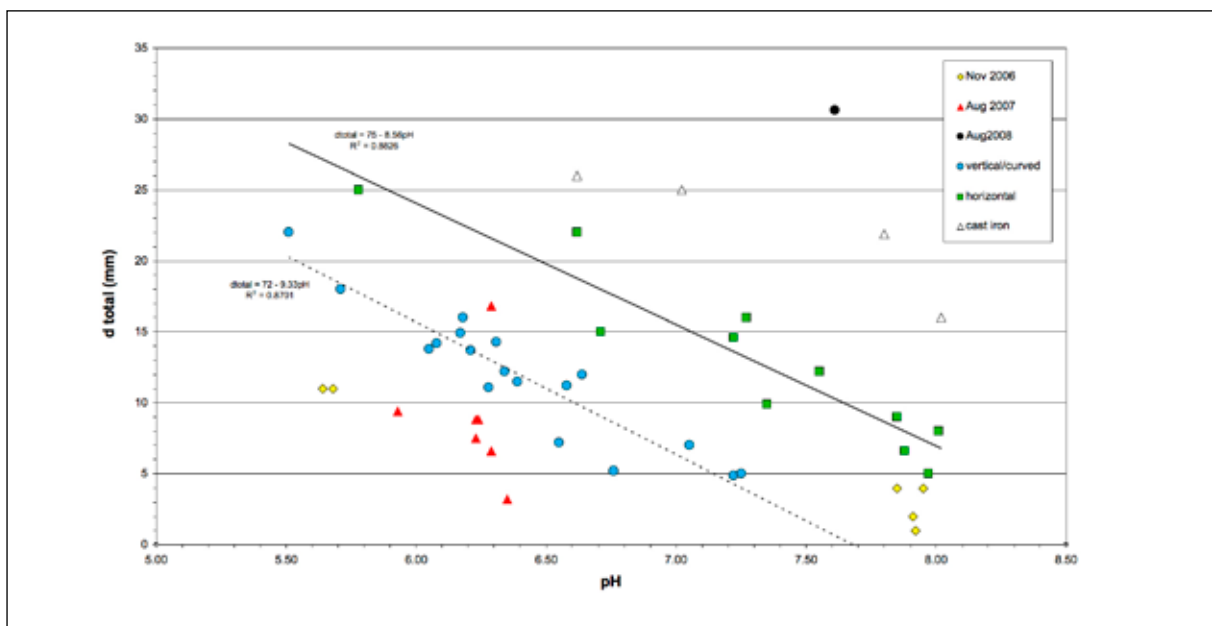
Figure 9. Plot of total concretion thickness versus metal pH on the Tonoas dock boat.

When the data on the total thickness of concretion and the corrosion products (d_{total}) is plotted as a function of pH (Figure 9) there are two main lines at the upper and lower sections of the graph which clearly conform to a linear relationship between d_{total} and pH. That is, the pH of the corroding residual metal interfaces decrease linearly with increasing total thickness of the corrosion product layer and the encapsulating concretion. The line with the highest d_{total} intercept at a formal zero pH (equation 4) relates to sections of the vessel that are primarily horizontal plates or surfaces (e.g. deck plates, etc) while the lower line (equation 5) corresponds to sections of the vessel which have either a vertical or a curved nature i.e. the gunwales, the hull plates and other related structural members.

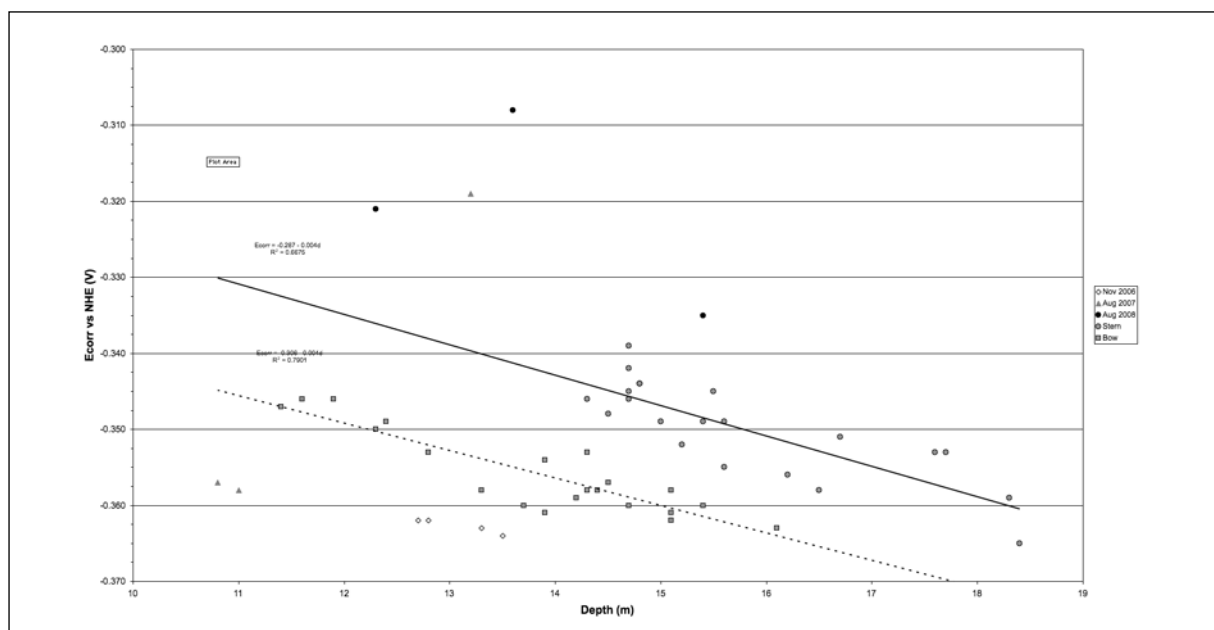
Figure 10. Plot of corrosion potential versus water depth on the Tonoas dock boat.

When the E_{corr} data for the three field seasons on the Tonoas dock boat were plotted against water depth (Figure 10) it is obvious that there are two distinct clusters of data points. The data set with the highest (least negative) E_{corr} values were those measured around the stern and the engine house area and were about 20mV more anodic than the other data set measured predominantly around the bow area possessing lower (more negative) E_{corr} values. The more anodic values reflect a 15% increase in the corrosion rate, based on calculated values for the difference in the voltage intercept values and the known average value of 320mV difference in voltage equating to a ten fold difference in corrosion rate (MacLeod 1995). This indicates that the stern section is corroding at a faster rate than the bow area, which can be explained by the fact that there is obviously some form of galvanic corrosion occurring around the stern area with this aft section being in direct

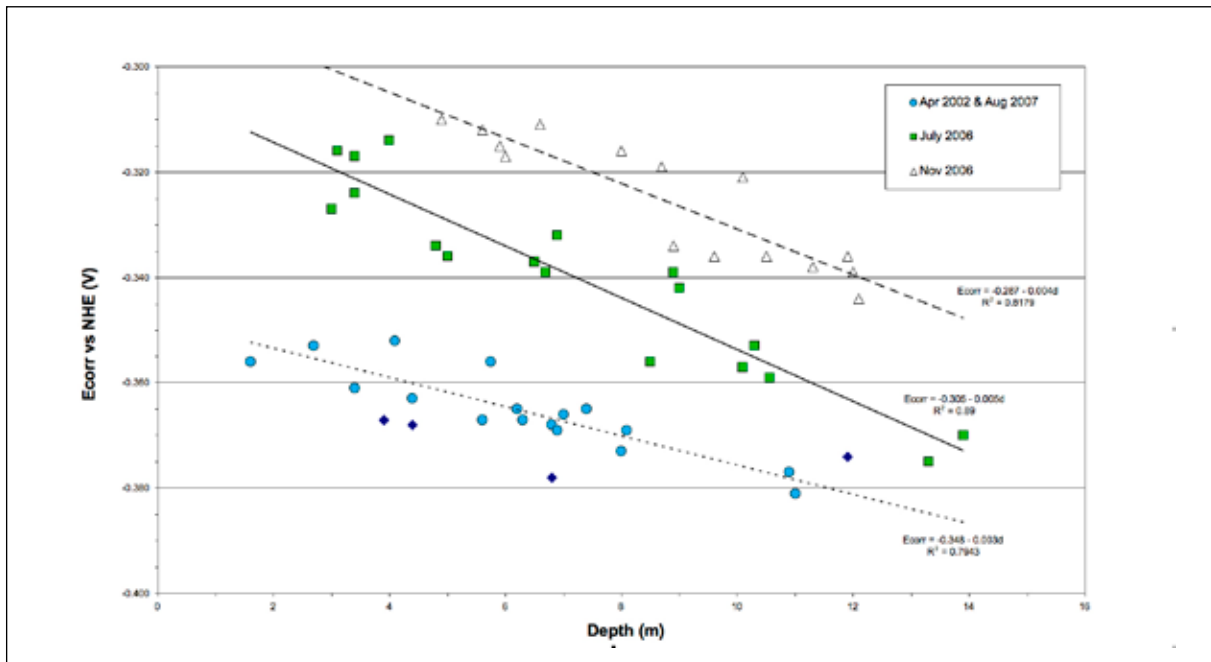
Figure 11. Plot of corrosion potential versus water depth on the Susuki patrol boat.

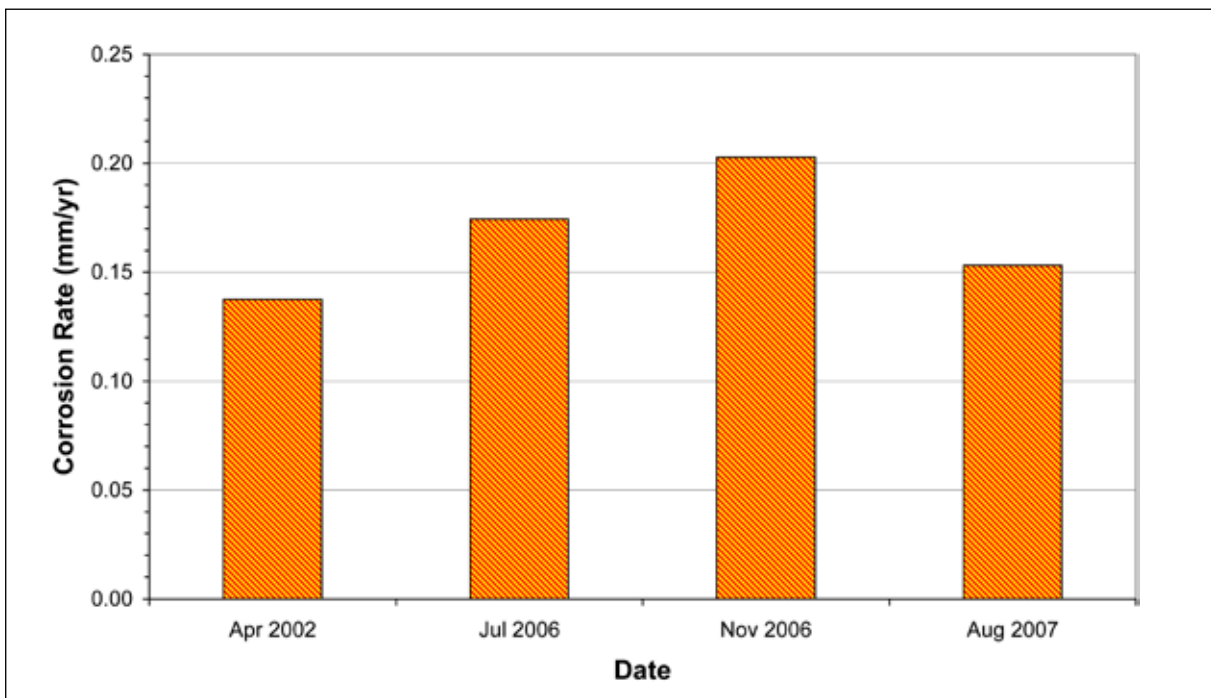
Figure 12. Plot of Susuki corrosion rate versus time.

The changing corrosion rate at the various measurement intervals is illustrated in Figure 12 where the initial rate of 0.14 mm.yr⁻¹ increases to 0.17 then 0.20 and finally falls to 0.15 mm.yr⁻¹ in 2007. The initial corrosion rate was calculated using equation 1 for shallow wrecks in Chuuk Lagoon (MacLeod 2006), based on mean water depth of the site, and the subsequent measurements were calculated according to the standard change of 320 mV in E_{corr} for a tenfold increase in corrosion rate (MacLeod 1995). The greatest difference between the mean E_{corr} values April 2002 and the data in November 2006 represents a 47% increase in corrosion rate. The trend in the corrosion rates of the vessel is also reflected in the way in which the mean pH decreases, i.e. as the corrosion rate increases the concentration of Fe²⁺ ions underneath the protective layer of concretion increases and the extent of hydrolysis concomitantly increases and so the pH falls. This data shows that wreck sites are in a dynamic equilibrium with the marine environment and that when damage occurs there can be relatively rapid recovery to pre-disturbance levels.

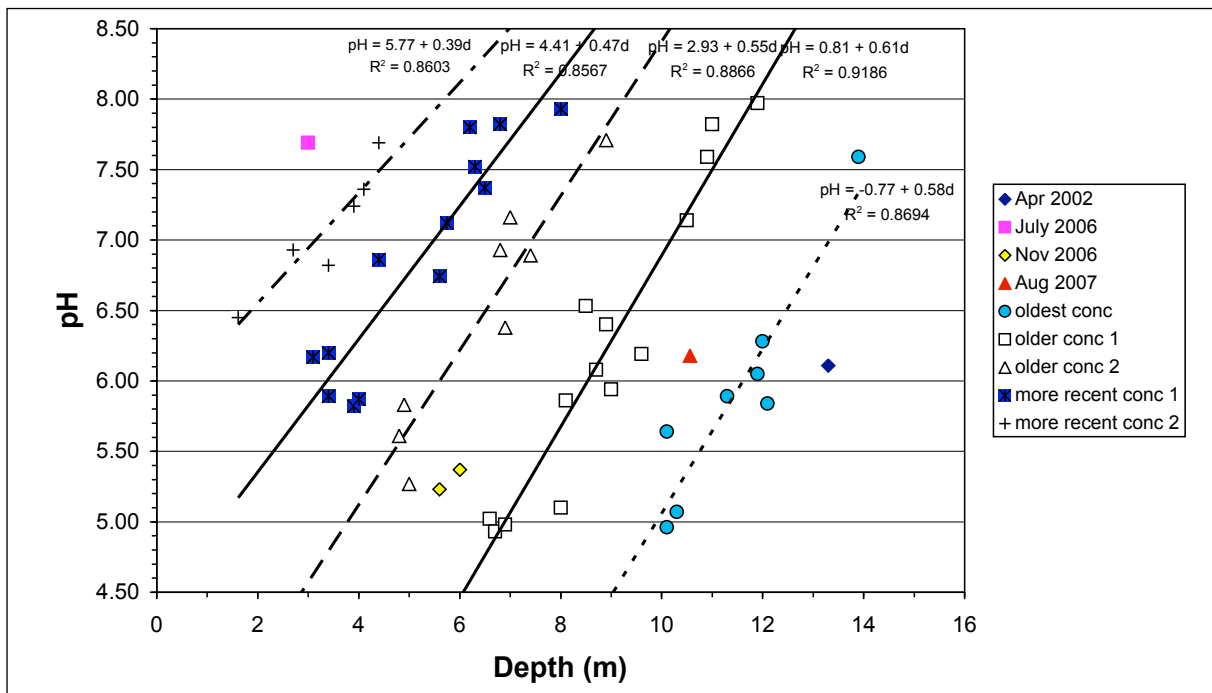
Figure 13. Plot of metal pH versus water depth on the Susuki patrol boat.

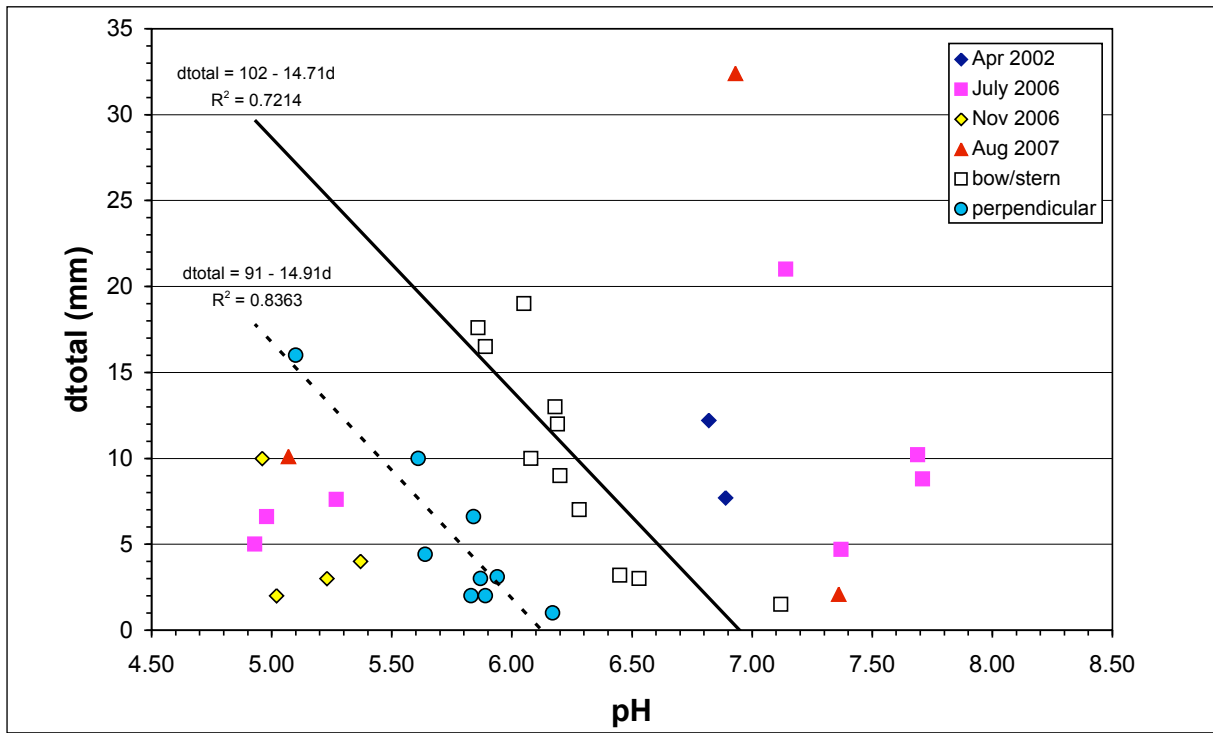
Figure 14. Plot of total concretion thickness versus metal pH on the Susuki patrol boat.

When the thickness of concretion on the *Susuki* is plotted as a function of pH (Figure 14) the same types of relationships observed with the *Fujikawa Maru* and the Tonoas dock boat were found for the older concretions which represented more than half of the measurements. There was a linear increase of d_{total} with the increasing acidity of the metal interface as seen in the two trend lines illustrated in Figure 14. The thicker concretions

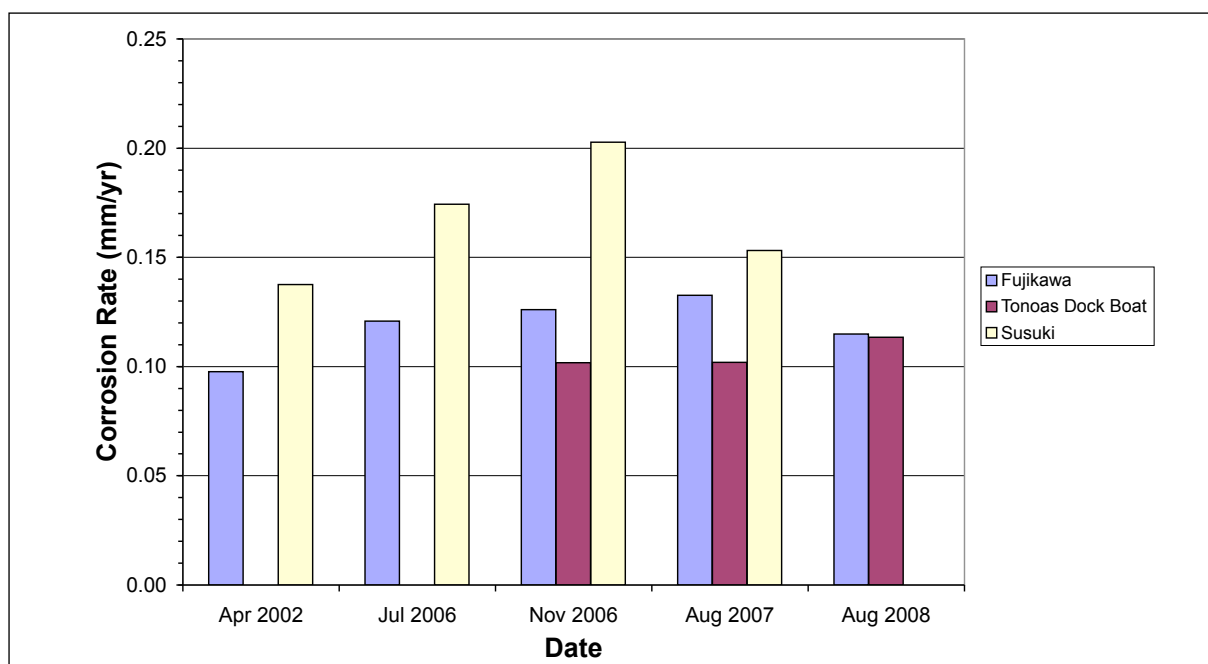
Figure 15. Plot of corrosion rate on all wrecks versus time.

The impact of 'dynamite fishing' on the wrecks can be seen in the way in which the mean E_{corr} , and the associated corrosion rate, changes with the seasons of measurement due to deconcreting events (Table 1 and Figure 15). The corrosion rate for the Tonoas dock boat is constant within experimental error, which is in marked contrast to the *Fujikawa Maru* and the *Susuki* patrol boat. For the *Fujikawa Maru* the 2002 mean E_{corr} was $-0.377 \pm 0.018 \text{ V}$, which increased to $-0.359 \pm 0.009 \text{ V}$ in July 2006, a 14% increase in corrosion rate probably caused by a 'dynamite fishing' event. Within the space of five months the E_{corr} fell

The only effective method for reducing corrosion rates on these historically significant shipwrecks is to improve management practices such as provision of permanent moorings and improved policing of the existing protective legislation. In addition, education training programs for dive tourism operators to move towards a more sustainable interaction with the wrecks would greatly assist the recovery of the wrecks from past damage and intervention. In addition, there is the risk of perforation of fuel bunkers on some vessels, possibly releasing petrochemicals into the fragile ecosystem potentially causing significant environmental damage in Chuuk Lagoon. Hence there is an urgent requirement for additional funding to be provided to the

Chuukese government to enable longer in situ corrosion monitoring and the installation of cathodic protection systems to be installed onto 'at risk' wrecks.
