# The effects of storms and diving activities on the corrosion rate across the SS *Yongala* (1911) site in the Great Barrier Reef

## Abstract

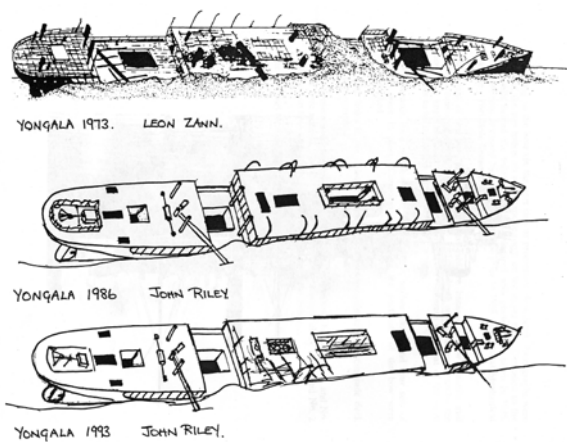
Figure 2. Isometric projections of the 'Yongala' showing progressive deterioration of superstructure and sand coverage-scouring episodes.

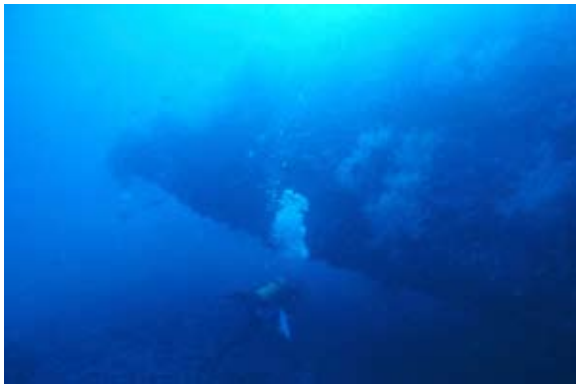
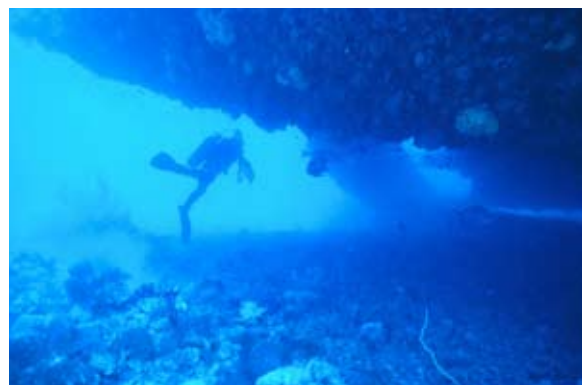
Severe scouring of the site can at times lead to major sections of the vessel being unsupported which places it under considerable mechanical stress, for although corrosion will have thinned the metal, the resulting matrix of remaining hull and associated concretions will be significantly heavier than the original design ever envisaged, and the reduced metal thickness becomes increasingly unable to sustain the increased stress loads (MacLeod & Romanet 1999). Once the combined effects of corrosion and concretion formation render the component elements unable to be sustained, parts of the wreck break away. Scouring events, such as those of May 2007, result in parts of the vessel losing support from the surrounding sediment (e.g. the starboard side gunwale was predominantly exposed in areas outside the citadel or mid-ships during this scour event). The progressive degradation of the site has been mapped through a series of isometric sketches in 1973, 1986 and finally in 1993 (Figure 2). A significant amount of deck plate has corroded away and it is possible to swim the length of the vessel with views inside, as reported by Cropp in 1976 (Cropp 1980). The scouring had also fully exposed areas under the bow and stern and

Figure 3. Images of 'Yongala' showing major scouring events had taken place prior to a 2001 site visit. Photos: Bill Jeffery.

at times, nearly the entire forecastle deck of the vessel was suspended above the seafloor as evidenced through Bill Jeffery's photographs taken in 2001 (Figure 3). The removal of the bronze propeller by a salvage company in the 1970s removed a large weight from the stern end of the vessel and removed the detrimental effects of galvanic and proximity corrosion (North 1989).

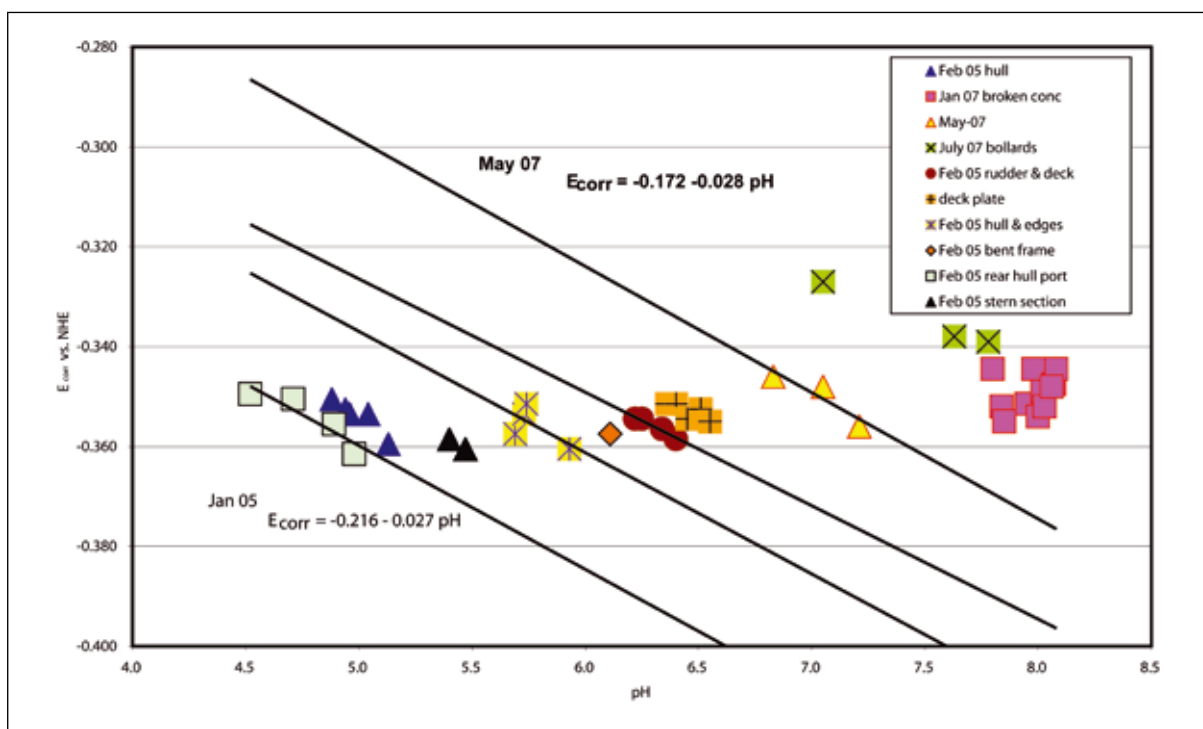
Figure 5. Plots of the  $E_{corr}$  and pH data showing different corrosion microenvironments

Plots of the corrosion potential, measured against the  $Ag/AgCl_{sea}$ , but standardised against the Normal Hydrogen Electrode (NHE), show that the measurements fall into a series of parallel lines, as shown in Figure 5. The same slopes indicate a common corrosion mechanism. When parts of the site have the same voltage but different pH values, the more alkaline pH points generally reflect a lower corrosion rate. The pre-disturbance data shows that the most acidic points are located at the rudder post and hull plates just aft of the citadel due to localised turbulence despite the protective concretion cover (MacLeod et al. 2007). Thus the sheltered horizontal deck plates had a mean pH of  $6.43 \pm 0.07$  while the hull plates had a mean pH of  $4.99 \pm 0.10$  due to differences in the flow of oxygenated seawater over the concreted surface. All the in situ data from the 2005 and the 2007 surveys had the common slope of slope of  $-0.026 \pm 0.003$  which is consistent with the corrosion mechanism on historic iron

The  $E_h$  and pH data from 2007 have generally less negative voltages and lower pH which shows the site is corroding at an increased rate. Substantial concretion losses occurred when storms on 26th March 2006 from Cyclone Larry tore off the protective marine growth at the bow and other locations. The impact of the cyclone damage is equivalent to a 37% increased corrosion rate as seen in the 44 mV separation of the intercept values for the  $E_{corr}$  and pH data shown in Figure 5. The cyclone also caused premature failure of a dive boat mooring buoy and dive operators in April 2007 reported losses to the metal hull and deck plate (Crocombe & Batrick 2007).

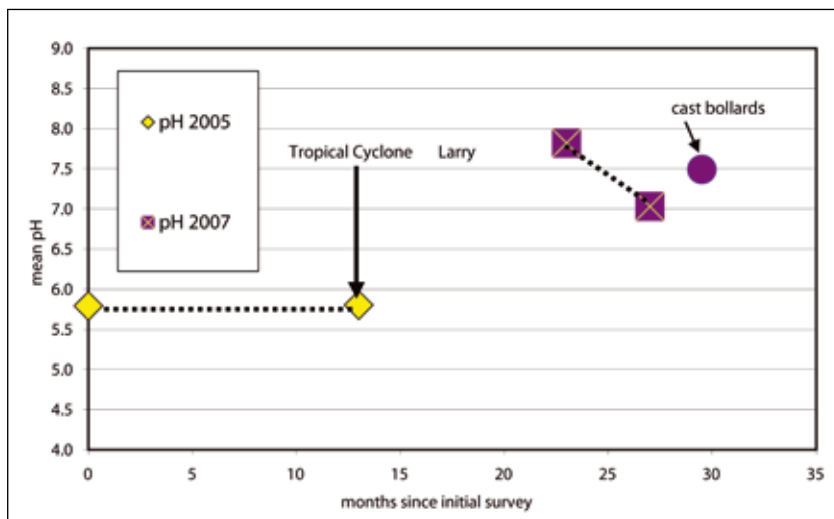
Figure 6. Plot of mean pH of steel plate and cast iron before and after Cyclone Larry in 2006.

of the alkaline seawater are the reason why the January 2007 data has very alkaline pH values. The trend in pH values can be seen in Figure 6, which shows that the cyclonic concretion damage was responsible for the initial alkalinisation of the pH but renewed colonisation by marine organisms saw the underlying acidity increase as the system moved back towards its previous dynamic equilibrium.

At the initial rate of recovery it is estimated that the site will take  $20 \pm 4$  months to recover from the cyclonic damage which is consistent with iron shipwrecks in Chuuk Lagoon recovering from damage to concretion from dynamite fishing (MacLeod and Richards 2010).

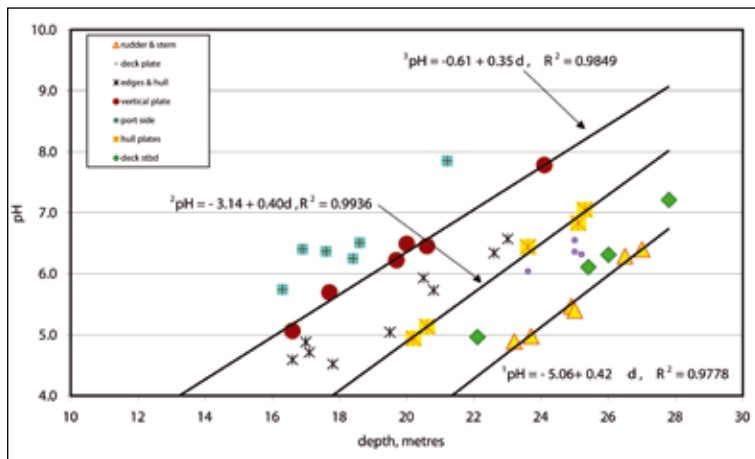
The main feature of the pH vs. depth data (Figure 7) is that much of it falls along parallel lines which show the same depth dependence and hence they have a similar local corrosion microenvironment. Eight data sets gave a mean slope of  $+ 0.40 \pm 0.02 \text{ pH.m}^{-1}$  which is the same as the *Gosei Maru* and the *Hino Maru* in Chuuk Lagoon in the Federated States of Micronesia. Since the pH is a logarithmic function of the hydrogen ion concentration which is directly linked to the concentration of  $\text{Fe}^{(II)}$ , it follows that the logarithm of the corrosion rate decreases linearly with depth (MacLeod 2006). As previously noted cyclonic damage to the wreck site means that pH data near the bow and along the port side of the citadel are not reflective of the underlying corrosion rate. The

well scoured stern had the highest acidity because its concretion had not been damaged by the cyclone whereas the bow and the citadel areas had been significantly affected. The entire near vertical hull plates and sections of the bridge have pH values 1.6 more alkaline than other nearby structural elements which means they have a noticeably lower

corrosion rate. High profile areas such as the funnel opening in the raised central citadel, the starboard side of the citadel structure and the promenade deck have higher corrosion rates because of the greater profile they present to the movement of the sea water.

Figure 7. Plot of pH as a function of depth, location and aspect.

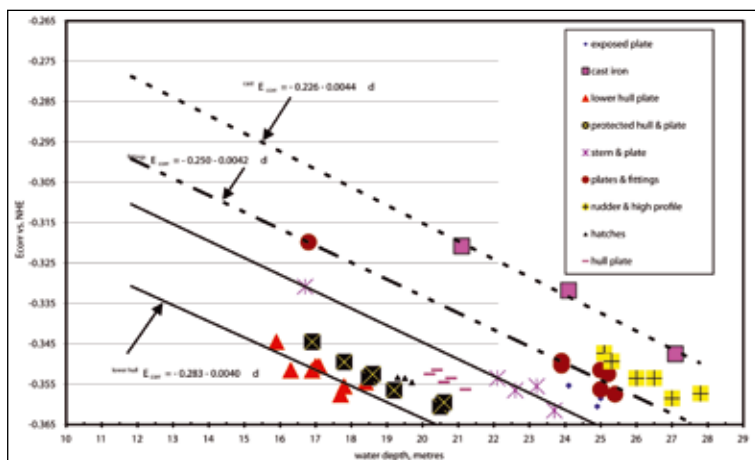
The  $E_{\text{corr}}$  data was plotted against both the as recorded values from the  $\text{Ag}/\text{AgCl}_{\text{sea}}$  reference electrodes and also against the Normal Hydrogen Electrode and the results are essentially the same in that the voltages became increasingly negative with increasing depth. The greater sensitivity of the  $E_{\text{corr}}$  values to water depth on the *Yongala* of  $-4.2 \pm 0.2 \text{ mV}$  per metre compared with  $-2.2 \pm 0.2 \text{ mV.m}^{-1}$  for the Japanese wrecks in Chuuk Lagoon is likely due to the more exposed nature of the site in the open ocean waters. (MacLeod 2006). The most corrosive areas of the wreck were located at the bow at the port bollard, low down on the stem and also at the port side of the hull at the bow and also at the stern the voltages were also high at the counter stern and around the rudder (see Figure 8).

The most and least corrosive areas of the wreck are separated by a difference of 35 mV or 29% different corrosion rates at the same depth between the lower hull plates and the high profile areas in and around the stern. It is likely that one of the reasons why the vessel has remained intact is because of the massive amount of marine concretion covering the wreck which provides mechanical strength to overcome the weakness of the metal that has been lost through 92 years of corrosion.

Figure 8. Plot of  $E_{corr}$  vs. depth for the 'Yongala' site over all seasons.
