## **Channel Deepening Project Supplementary Environmental Effects Statement**

### **Assessment of potential impacts to the long-term corrosion rates of shipwrecks in Port Phillip Bay**

**Dr Ian D. MacLeod  
Western Australian Museum**

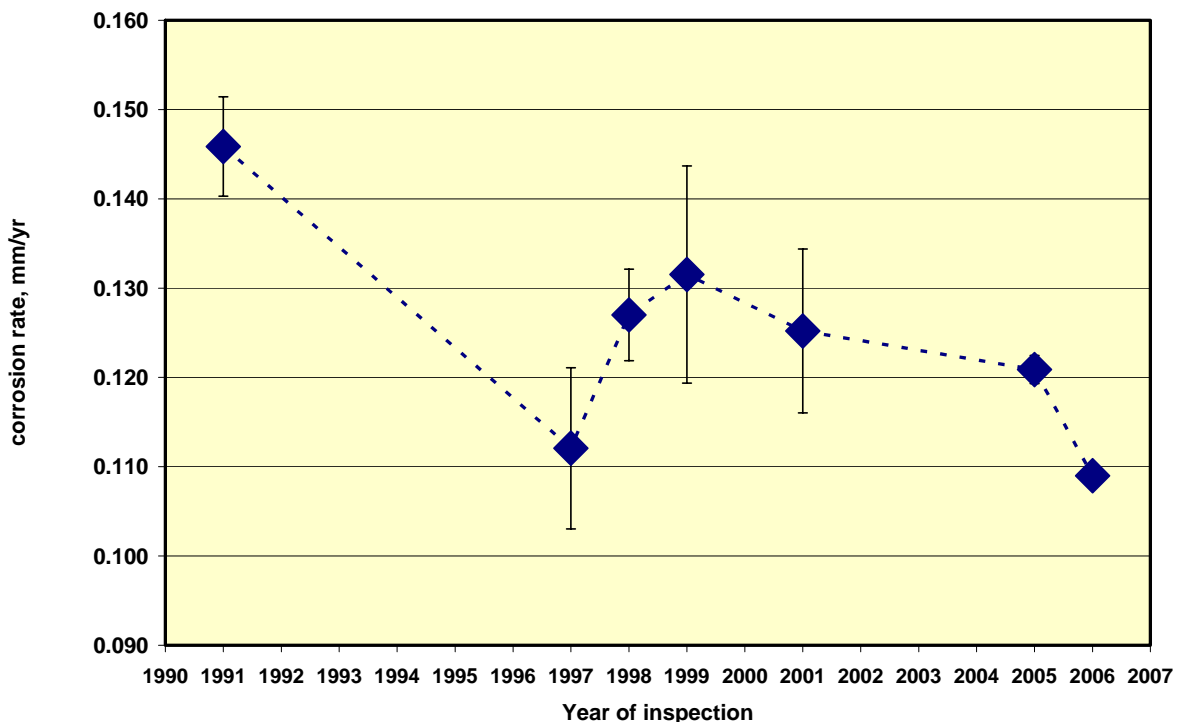
A series of in-situ corrosion measurements were conducted on the wreck *City of Launceston* (1865) in Port Phillip Bay between 1991 and 2006 which have confirmed that the vessel is close to collapse. The apparent long-term corrosion rate is  $0.119 \pm 0.014$  mm/year which indicates that the average hull plate thickness will have fallen to less than 1mm of steel by the end of 2005. In this condition it is unlikely that the vessel will be able to withstand the impact of the strong storms that periodically dominate the weather patterns in Port Phillip Bay but the integrity of the site is partly assured through the retention of the concerted corrosion matrix across the hull, engine and fixtures. Interpretation of the *in-situ* corrosion parameters are at times complex, owing to the interconnected nature of steel plates, frames and stanchions.

Figure 1: Plot of corrosion rate of the *City of Launceston* from 1990-2006

However, the surface pH of the corroding metal was found to be more representative of the local corrosion rate and can be used to establish the most likely sites for disintegration of the hull. Corrosion data has provided evidence of the detrimental impact of weed clearing (1997) but has also enabled the impact of re-colonisation to be determined and formed the basis for opening up the site to controlled diving tourism. The data shown in Figure 1 illustrate the beneficial effect of the cessation of scallop dredging after the 1991 inspection. Owing to the corrosion data indicating that the vessel had less than 7 years life as an intact iron wreck, the full archaeological survey and systematic excavation were undertaken. Although this work had a deleterious effect on the rate of corrosion, the recolonisation of the site and the decreased turbidity resulted in a significant decrease in

the rate of decay of the wreck. Given the location of the *City of Launceston* with regard to the zones where channel dredging is planned, it is unlikely that any increased degradation will occur as a result of changes brought about by the Channel Deepening Project.

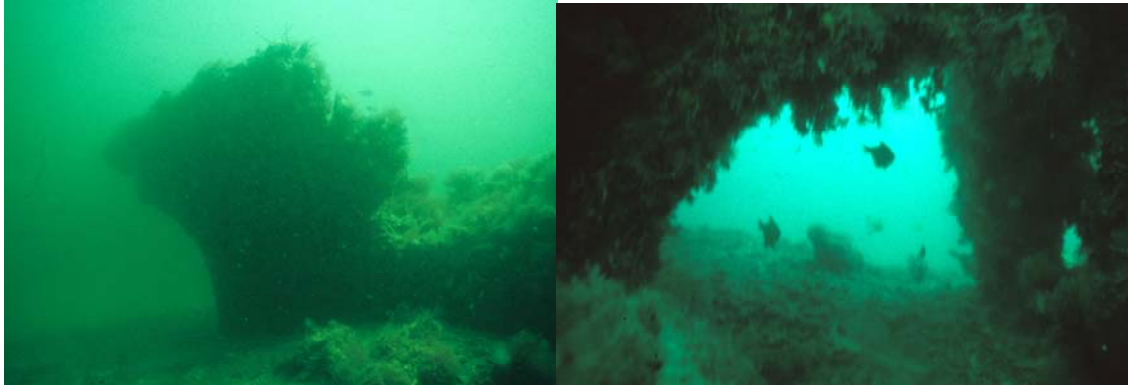
Figure 2: *City of Launceston* bow and stern sections showing concreted marine iron in 2002.  
© Heritage Victoria

If there is any report of major changes to the nature of the stability of the wreck after the channel deepening project has been concluded, the most likely cause of such changes will be due to the age of the wreck and that fact that it is ready to undergo a significant change in its profile on the seabed i.e. it is an impending state of advanced decay.

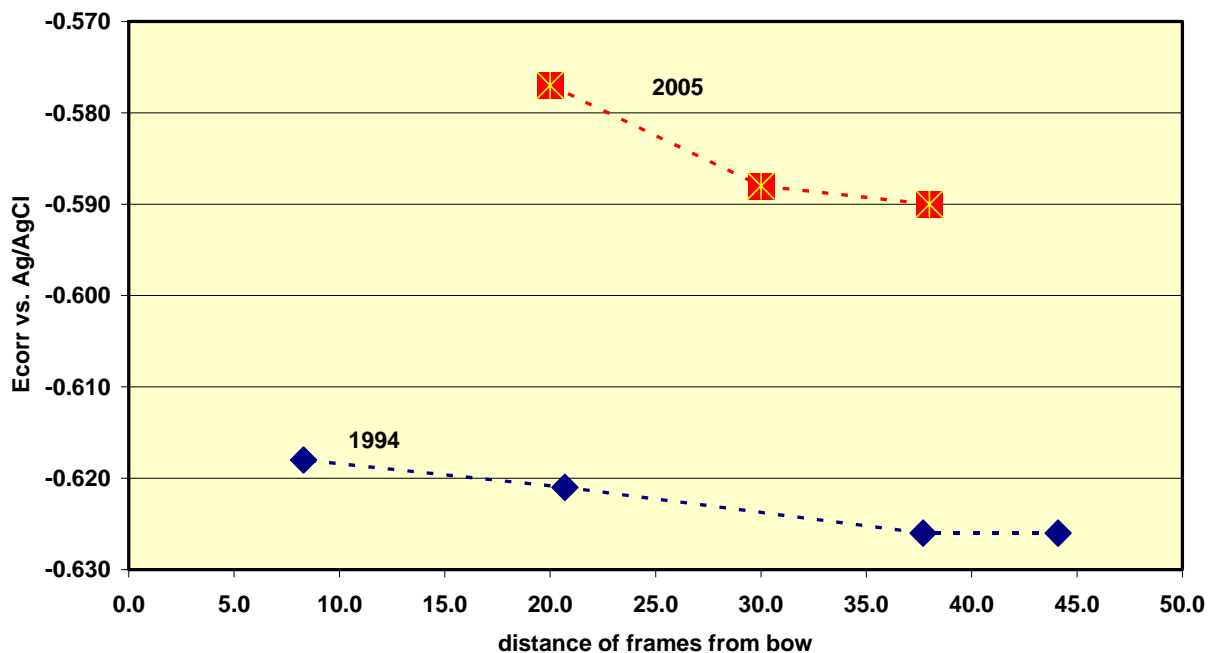
HMVS *Cerberus* 2005 vs 1994

Figure 3: Plot of the E<sub>corr</sub> of the HMVS *Cerberus* frames as a function of time.

With concreted marine iron, a less negative E<sub>corr</sub> value indicates that the object is corroding at a faster rate than those which have a more negative value. The data in Figure 3 clearly indicates that the HMVS *Cerberus* is in an advanced state of decay and that the rate of corrosion has increased between 1994 and 2005 by approximately 24%. Some work has been done to stabilise the structure and this has involved the removal of the four massive guns from the two turrets in the hope that the reduced weight will lessen the stress on the armour belt and deck.

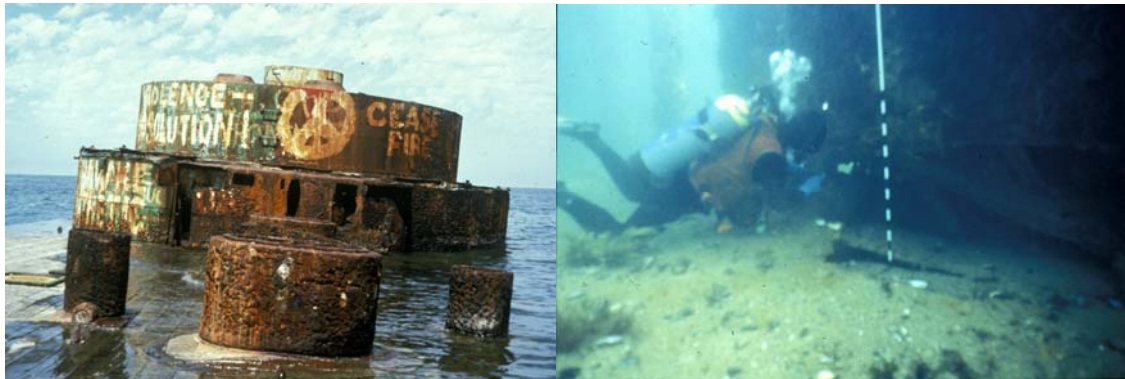
Of great concern is the scouring around the stern of the wreck which has seen a large hole, about 2 metres deep, develop around the counter stern. This has exposed the wreck almost to the keel, which is lying directly on the bedrock of the ocean floor. One advantage of this scouring is that it is possible to determine that the average amount of sand cover around the wreck is about two metres and this can have important implications for the erection of any protective devices such as sea walls or cofferdams. The scouring did allow much better viewing of the remaining structural elements which are supporting the vessel and these look very thin and it is unlikely that the vessel will continue to be stable in another heavy storm. With the lack

of support around the stern it is likely that another surge will see the rear of the *Cerberus* break off around the line of the aft turret. If this occurs the only realistic option is to let the vessel gradually collapse and become a managed dive site. Once the collapse has been completed, the wreck could be filled with sand, to prevent penetration diving, and the site managed with glass-bottomed boats having rights to take tourists to the site and to view it from above.

Figure 4: HMVS Cerberus above and below water in 1999, with the author inspecting hull plates  
© Heritage Victoria

It is not possible at this point to determine which options are the best to follow since we do not have data on residual metal thickness of the supporting frames and deck beams under the turrets. If the original specifications can be found it is possible to do an estimate of the residual thickness. Present indications are that the steel was 1/2" thick and if this is the case, it is likely that there will be only a few mm of sound metal left in this structure. It would be wise to perform some detailed review of this issue since if there is essentially little material to support the overall integrity of the deck, then any attempts to support one section and to raise the profile back to the pre-collapse levels could result in the vessel breaking its back and good money being wasted. Engineering calculations need to be made to see if the stabilisation option is realisable. This work should be done prior to commissioning any work on building a cofferdam or any other such stabilisation works around the wreck. There seems to be little point in pursuing a major engineering works program of building a protective wall or barrier around the wreck if it is not going to be able to lead to the overall desired outcome of preservation of the original profile of the wreck.

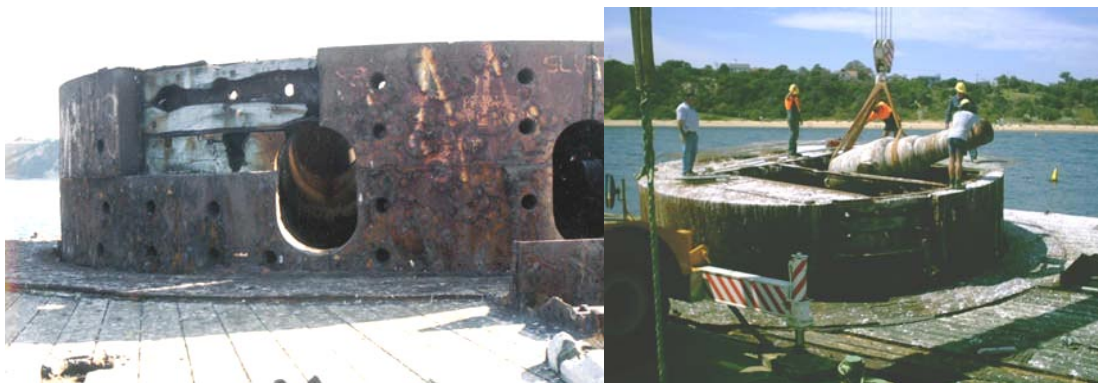
Figure 5: HMVS Cerberus with guns removed from one turret and being extracted from another 2004  
© The Age

Despite the good work done to stabilise the upper works of the HMVS *Cerberus*, the long exposure to the highly corrosive splash zone environment of being part in and part out of the water has meant that major decay of the ships internal structures has taken place since 1926. Given that there is no form of support for the vessel and that it is currently split at the bow, it is very likely that a naturally occurring storm will produce sufficient wave action to cause a further major collapse of the wreck. Such events are to be expected within the normal “once in ten years” storm cycle and should not be considered to have anything to do with the channel deepening project. The nature and the extent of the changes to the local marine environment caused by the channel deepening project mean that it will have a negligible effect on the fate of the HMVS *Cerberus*.

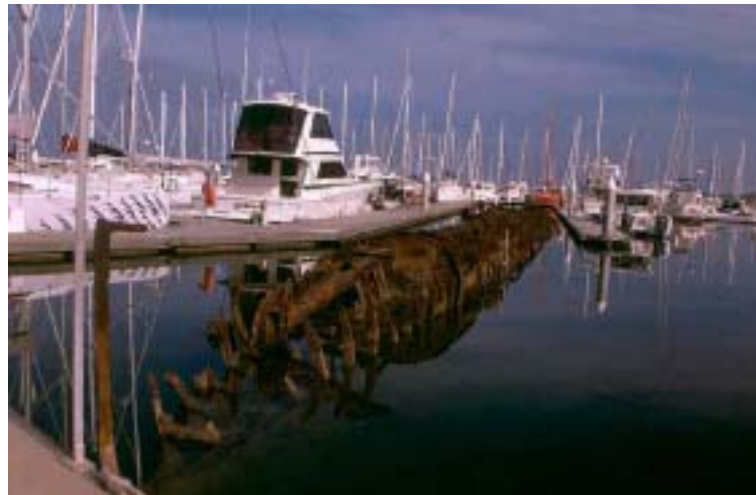
The vessel was inspected in January 2005 and found to be in an advanced state of decay with significant elements such as the stem being loose to touch and several frames had become electrically disconnected from the remains of the submarine which lie deeply settled in a very fine silted bottom of the Sandringham Yacht Club (see Figure 6). The bow is completely corroded and the whole general degradation processes are similar to those of the HMVS *Cerberus* in that the vessel is part in and part out of the water. The upper parts of the outer hull plating are significantly corroded and only the frames remain. The diving planes which are still in position. Owing to the fact that the submarine is in the lee of a number of pontoons it is relatively sheltered from the normal

fetch and toss of wave action, unlike the HMVS Cerberus which is fully exposed to the corrosive forces unleashed by fully oxygenated seawater.

Figure 6: J Class submarine J7 at the Sandringham Yacht Club, © Heritage Victoria

Given the location of nearby 240 volt AC power it is a relatively simple process to purchase an appropriate DC rectifier unit and mixed metal oxide anodes and protect the submerged part of the submarine. The external and exposed upper works could be treated with a fish oil based product and this would prevent the ingress of moisture and greatly reduce the corrosion rate. Given that the wreck lies well within the yacht club boundaries the major environmental factor affecting its rate of deterioration is the increased water movement associated with recreational boating activities in the pens which are immediately adjacent to the wreck. It is most unlikely that the J7 submarine will suffer any adverse effect that could be ascribed to changes in current or physico-chemical changes brought about by the Channel Deepening Project.
