Conservation of Corroded Metals: A Study of Ships' Fastenings from the Wreck of HMS Sirius (1790)

IAN DONALD MACLEOD

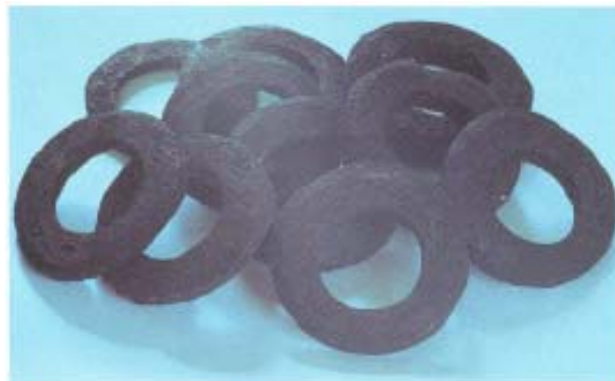
FIGURE 1.

*Clinch rings from
the HMS Sirius.*

In the field seasons of 1985, 1987, and 1988, a team of maritime archaeologists led by Graeme Henderson of the Western Australian Museum's Department of Maritime Archaeology recovered a variety of metal artifacts from the wreck of HMS Sirius. The wreck is located on a coralline reef off Norfolk Island, which lies at 29.48° south latitude and 167.59° east longitude, about 1,500 km from Sydney and 1,000 km from Auckland, in the south Pacific Ocean. The copper, brass, and bronze objects recovered—including nails, bolts, sheathing, and other fittings (Figs. 1-3) were all worn and had apparently been used in the construction of the Sirius.

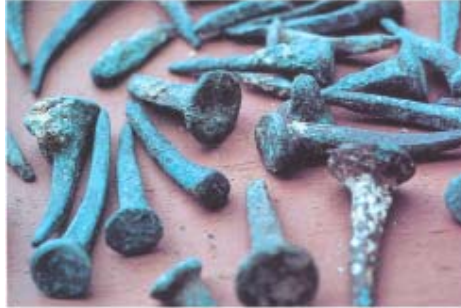
FIGURE 2.
Bronze sheathing
tacks *from* the
HMS Sirius.

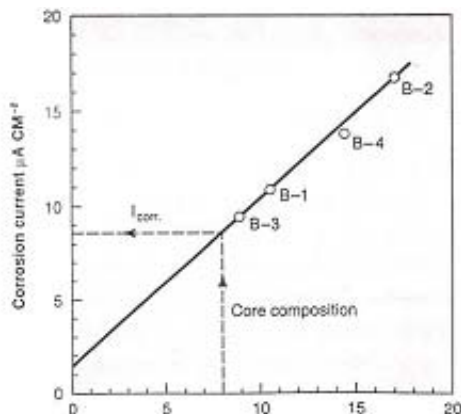
Figure 5. Diagram showing the effect of tin on the corrosion rate of a bronze sheathing tack (SI 228 B)

always been a major problem in stabilizing corroded artifacts to reliably determine what sort of variation is possible within one object. Results from the corrosion of the square-headed bronze sheathing nail (228B) illustrate the point. The corrosion current increases linearly with increases in the surface concentration of tin (Fig. 5), according to the equation:

$$i_{\text{corr}} = 0.886 x + 1.44$$

where x is the wt % tin in the sample and the corrosion current is expressed in $\mu\text{A}/\text{cm}^2$. The effect of the increased tin concentration is also seen in the corrosion potentials of the fastenings in oxygenated seawater: the lower the tin content, the more negative the E_{con} , and the lower the corrosion rate.

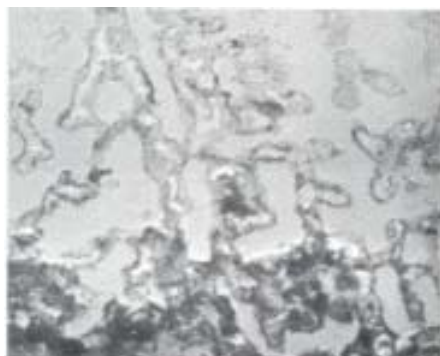
FIGURE 6. A scanning electron micrograph of the interdendritic corrosion at the seaward edge of an eroded bronze sheathing tack (SI 228A). Full width of the image is 306 μ m.

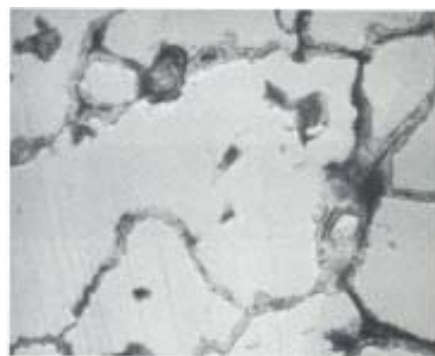
FIGURE 7. A scanning electron micrograph of the intergranular corrosion on a copper clinch ring (SI 254). Full width of the image is 306 μ m.

The copper clinch ring (SI 254) shows twice the corrosion rate of the copper sheathing (SI 357), as listed in Table 2. The reason for this is readily apparent from the differences in their microstructures. The sheathing has a very fine recrystallized structure as a result of extensive working, with typical grain sizes of 35-45 μm. Apparently, the large amount of non-metallic inclusions does not have a deleterious affect on corrosion performance. In contrast, the clinch ring displays severe intergranular corrosion. The small amounts of tin and lead, approximately 0.1 wt %, were apparently concentrated at the grain boundaries and promoted intergranular corrosion (Fig. 7). The iron impurities were also concentrated at the grain boundaries and also appear to be involved in the increased corrosion rate. The normally beneficial effect of arsenic as an inhibitor of intergranular corrosion may have been lost by the even distribution of the arsenic in solid solution.
