# Corrosion and conservation management of iron shipwrecks in Chuuk Lagoon, Federated States of Micronesia

Ian Donald MacLeod

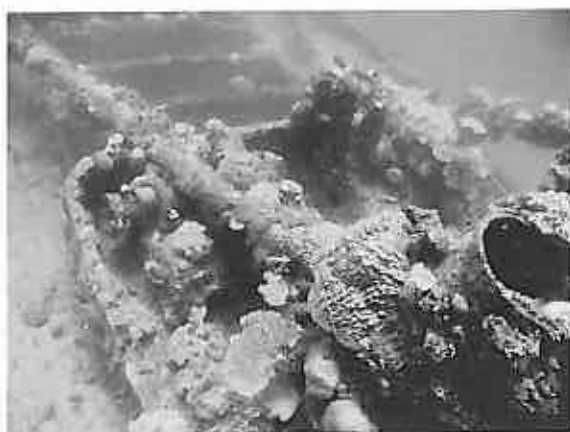
Figure 2. Extensive encrusting marine growth on the deck of the *Fujikawa Maru* with thicker growth surrounding the broken derrick. Photo Bill Jeffery.

oxidation of the metal occurring underneath the marine growth [6] as seen in Figure 2. Under such conditions the anodic, or oxidation, reaction is not the rate-determining step in the overall corrosion process; the controlling factor is the rate of reduction of the dissolved oxygen. The corrosion processes result in the inward diffusion of chloride ions from the sea, through the marine growth to the corroding metal, and the outward diffusion of the metal ions towards the sea surface.

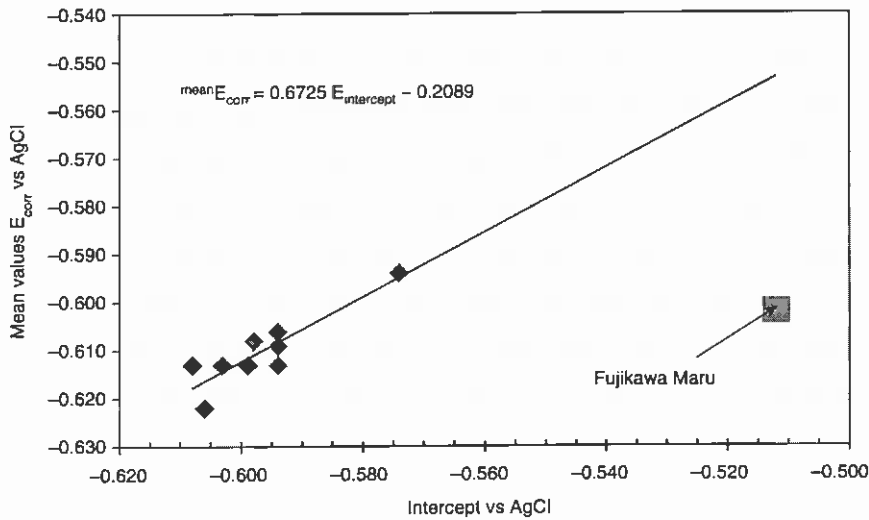
Figure 3. Mean  $E_{\text{corr}}$  values of hull plates versus the intercept values of the  $E_{\text{corr}}$  versus depth equations.

Since the extrapolation of the equations listed in Table 1 to zero water depth provides a measure of the relative corrosion rates of the iron wrecks at the seawater–air interface, the intercept values of  $E_{\text{corr}}$  at zero water depth were plotted as a function of the mean value of the corrosion potential of each of the wrecks. All the wrecks, apart from the *Fujikawa Maru*, illustrated that there was a definite relationship between the intercept values and the mean  $E_{\text{corr}}$  of each wreck, which is illustrated in Figure 3. The linear regression had a moderate correlation with  $R^2$  value of 0.7934, where  $R^2$  is the square of the correlation coefficient, and equation (1) defines the relationship

Since the *Fujikawa Maru* has a different corrosion mechanism to all the other wrecks it is not unexpected that its values for  $E_{\text{corr}}$  and the intercept are not described by equation (1) [17]. Inspection of the data in Table 1 indicates that the intercept of the  $E_{\text{corr}}$  versus depth equation for the *Fujikawa Maru* is greater than 80mV more anodic than all the other wrecks. The

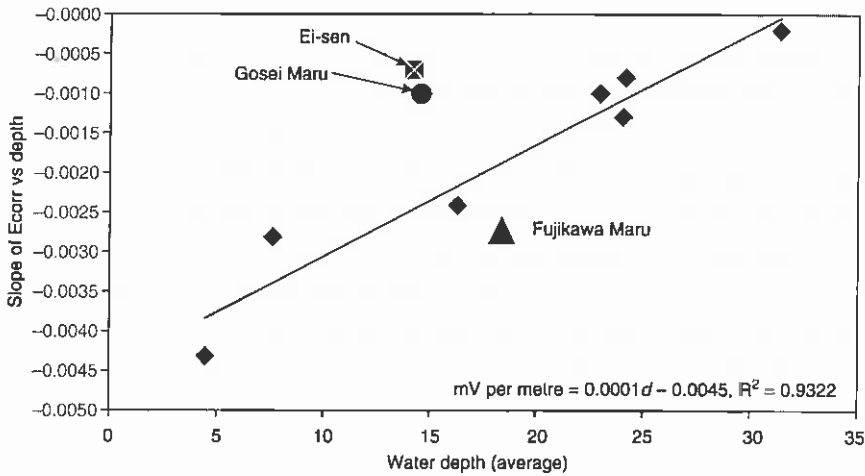
Figure 4. Plot of the slope of the  $E_{corr}$  versus depth as a function of mean depth.

where  $d_m$  is the mean water depth and the units of the slope are in volts per metre. The above relationship had an  $R^2$  value of 0.9322, which shows a very high degree of fit for the seven shipwrecks. When equation

(2) is integrated with respect to the mean water depth, the full relationship between  $E_{corr}$  and water depth is obtained. Thus the slopes of the  $E_{corr}$  versus depth plots for the seven wrecks are all the same and given by the relationship

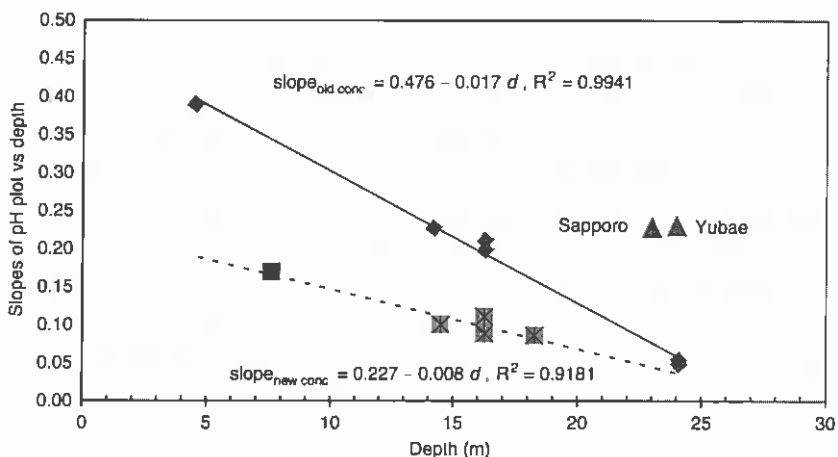
Figure 5. Plot of slope of pH on wreck sites versus water depth.

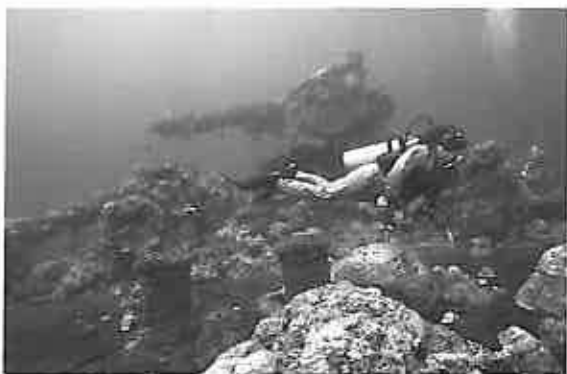
Figure 7. Gun from the *Hino Maru* showing exposed condition on the wreck site. Diver is Bill Jeffery, photo Jeremy Green.

them less reactive than the lower quality steel and cast iron used in their support structures and this will also lead to a localized form of preferential iron corrosion. The corrosion rate of the gun base on the *Hino Maru* is very similar to that of the stern bollard on the *Susuki Maru*, which is believed to have been preferentially corroded by its proximity to the large bronze propellers on the vessel [5] (see Figure 7).

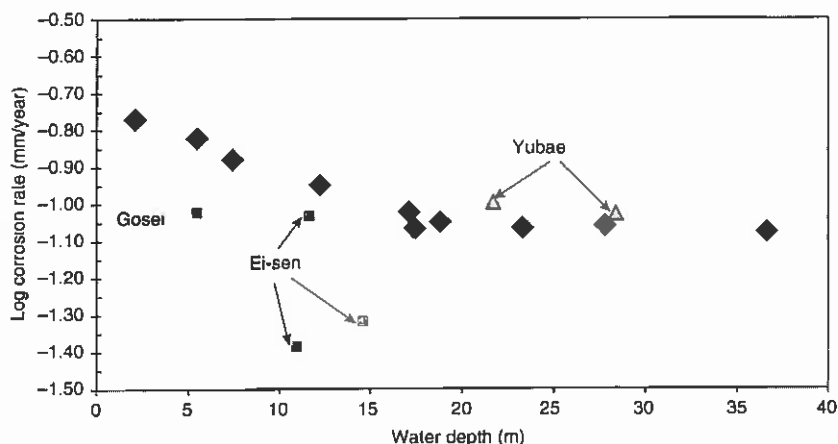
Figure 8. Plot of the log of the annualized corrosion rate for iron shipwrecks

This equation can be used to estimate the corrosion rate on other cast iron fittings and for other iron alloys, after a small correction for the ennobling effect of the carbon content. When equation (9) is used across the *Sankisan Maru* site, which ranged in depth from 2.1 to 19.7m, the mean corrosion rate was  $0.090 \pm 0.032$  mm/year; that is the same as the calculated rates of all the iron fittings and steel plates. Owing to the logarithmic nature of the corrosion rate on water depth, as shown in equation (9), the corrosion rate falls quite quickly with increasing depth. When the data in Table 5 are plotted as a logarithmic function, i.e.  $\log d_g$  against the depth, where  $d_g$  is the corrosion rate measured in mm of graphitization per year of immersion in mm/year, two distinct sub-sets of the general corrosion data become apparent, as shown in Figure 8.

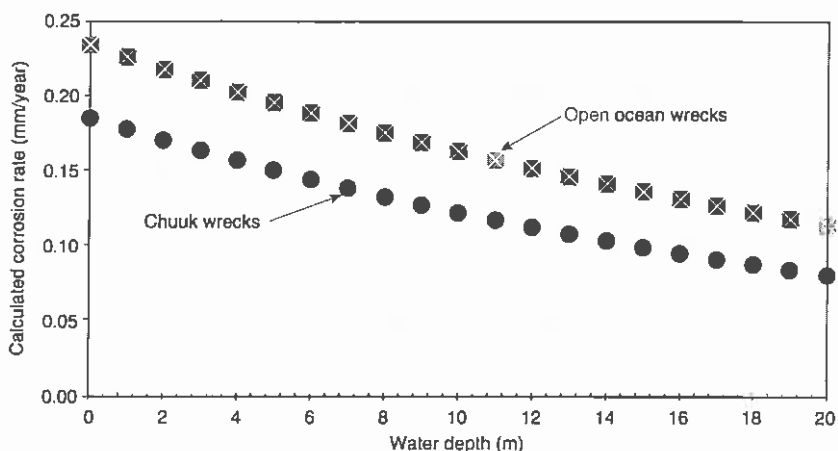
Figure 9. Comparative plot of predicted iron corrosion rates in open-ocean versus Chuuk lagoon.

the errors associated with the plots, so the slopes are statistically significantly different. The different slopes mean that the corrosion rate for shipwrecks in Chuuk Lagoon decreases 16% more than for open-ocean wrecks per metre of increased water depth. A summary of the equations used in calculating corrosion rates for shipwrecks in open-ocean environments and in the sheltered waters of Chuuk Lagoon is shown in Table 6. The impact of the lagoon environment on the overall corrosion rates of the vessels is readily apparent when the intercept values of the corrosion equations are compared, as seen in Figure 9 at the depth of 0m, where the annual corrosion rate for the Chuuk sites is 0.186mm/year or 21% lower than the open-ocean value of 0.235mm/year.

The lower corrosion rate of the Chuuk sites is essentially due to the more sheltered nature of the lagoon waters. The differences in corrosion rates increase with depth so that by 20m the Chuuk sites are predicted to be corroding 29% slower than the open-ocean analogues. The previous history of the vessels is also seen to have an impact on the way in which they are corroding. Those vessels that had been previously torpedoed and repaired (the *Shinkoku Maru* and the *Yubae Maru*) appear to be corroding faster than vessels that had no previous history of physical damage. It is likely that stresses in the steel, either from the accumulation of stress from having been blown up and repaired or the stresses associated with the catastrophic shipwrecking processes, are being reflected in elevated corrosion rates. An example of such processes may be the way in which hull plates are falling off the *Yubae Maru*, which is also stressed by lying upside down on the seabed [28]. Physical observations from divers and the historical record are of assistance in determining the nature of the deterioration processes and how to develop appropriate management strategies that address these issues.

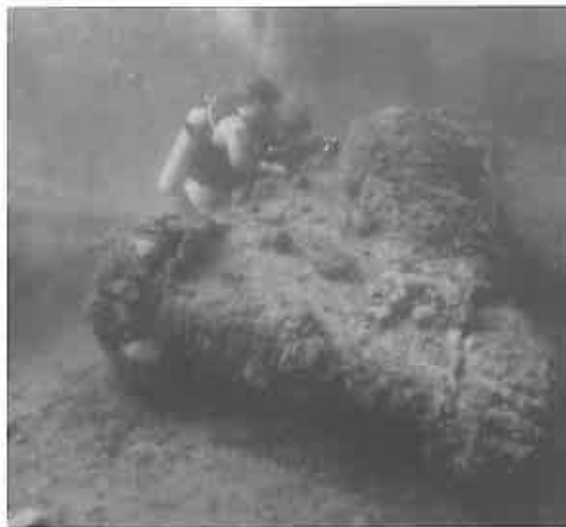
Figure 10. Conservators drilling into the turret of the Japanese light tank on the deck of the *Nippo Maru*. Note the extensive marine growth on the cast steel structure. Photo Bill Jeffery.

from the intercept of the Chuuk shallow-water corrosion rate equation. Further studies on this type of object are needed to fill in the data gaps between the *Fujikawa Maru* at 12.3m and the *Nippo Maru* tank at 37.7m, as seen in Figure 10.

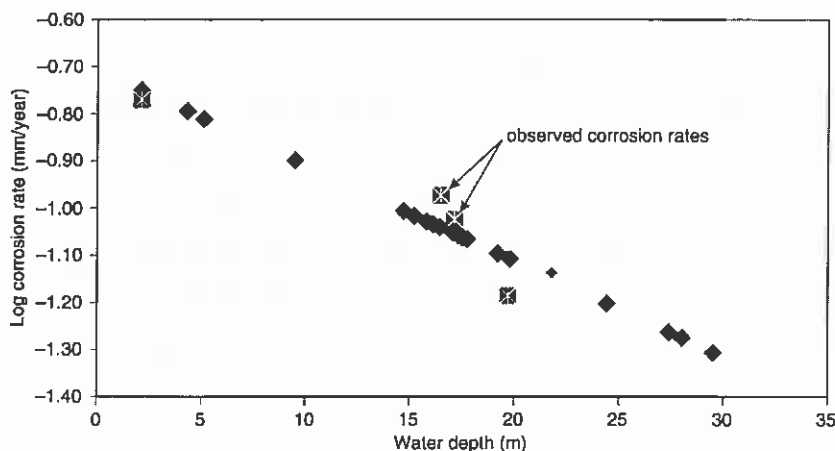
Figure 11. Logarithmic values of the calculated corrosion rate on the *Sankisan Maru*.

Results from the calculations are shown in Figure 11 and the mean of the calculated values was  $0.093 \pm 0.032\text{mm/year}$ , which is the same as the average value of  $0.090 \pm 0.032\text{mm/year}$  that was based on the observed depths of graphitization. The anomalously high corrosion observed on the windlass at 32mm in 60 years is probably due to a combination of galvanic action and very poor casting techniques and was not included in the calculation of the mean corrosion rate.
