The Effects of Chloride Ions on the Corrosion of Aluminium Alloys used in the Construction of *Australia II*

Ian D MacLeod and David P Kelly

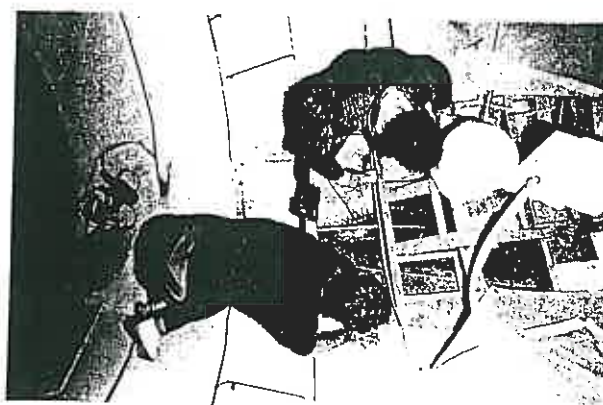
Figure 2. The authors inspecting the interior of *Australia II* sewer area, June 1987.

Five years elapsed between the initial accessioning of *Australia II* by the National Museum of Australia and its journey to Western Australia as an exhibition loan item. A request of the Maritime History curator Sally May for a condition report on the vessel led to an initial inspection of *Australia II* which showed the tell tale signs of its previous racing history. The fittings on the deck and inside the hull appeared to be in a generally sound but 'knocked about' condition. However, a detailed inspection of the sewer showed approximately eight litres of water trapped below the drainage holes, since the holes were not at the lowest point of the hull (Figure 2). This area was also partially inaccessible due to the mast box assembly.
