In situ conservation surveys of iron shipwrecks in Chuuk Lagoon and the impact of human intervention

Ian D MacLeod* and Vicki L Richards

Western Australian Museum

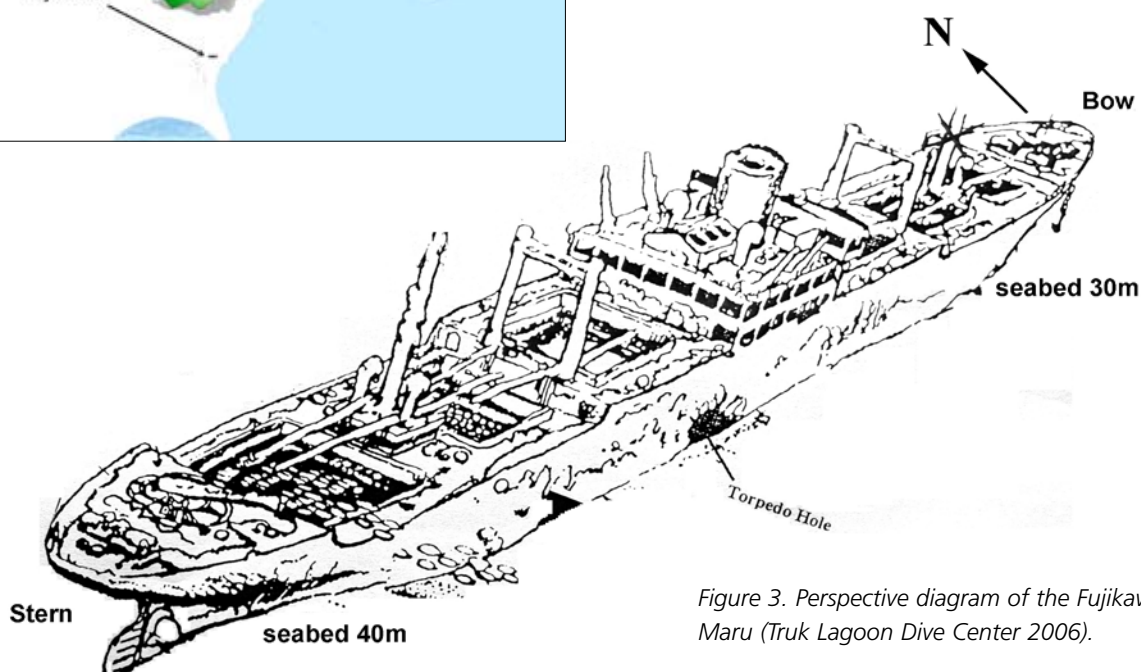
Figure 3. Perspective diagram of the Fujikawa Maru (Truk Lagoon Dive Center 2006).

is located in the channel between Fefan and Tonoas (or Dublon), south of Eten Island (Figure 2) and lies upright and proud of the seabed (Figure 3). The bow points east-south-east and the seabed slopes slightly to stern, where the depth to seabed is 40m, compared to the bow at 30m. The wreck lies in the natural channel between several islands, therefore the currents associated with the diurnal tide variations of ± 0.5 -1m has a relatively small impact on the extent of corrosion.
